# UltraSound

### Confidential Inspection Report

123 Sample Street  
Brentwood, TN 37027

Wednesday, June 13, 2018

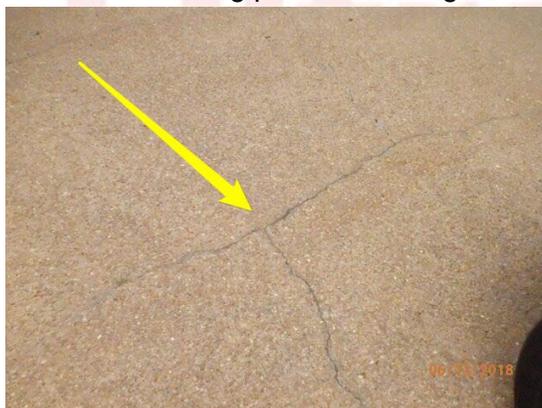
**FYI 11:** - Cracks were noted in the concrete driveway that are commonly seen by the inspector. Keeping cracks sealed is recommended to prevent moisture from penetrating the surface during freezing conditions causing possible damage.

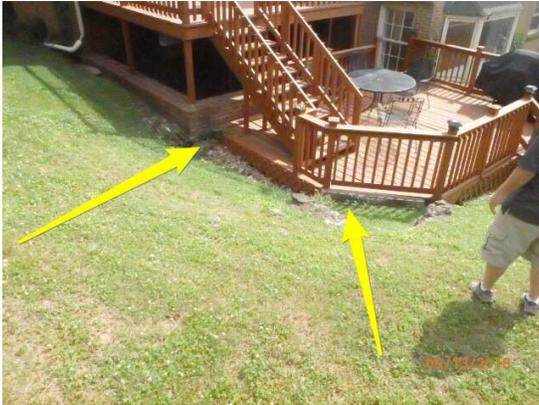
Areas of concern

**FYI 13:** - It was not determined if the rear portion of the yard is adequately sloped to channel the rain water around the sides of the structure. Additional grading and or underground drainage may be necessary. In addition, your inspector is not qualified to determine the makeup of the soil. If soil stability or expansive soil conditions are a concern, please consult a Geotechnical Engineer.

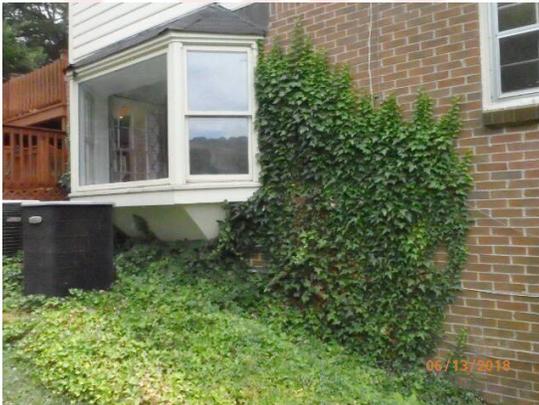
**REPR 14:** - The vegetation in the landscaping is in contact with the exterior wall and should either be removed or trimmed to give at least a 6" to 8" of clearance. This is needed to prevent direct access for insects to enter the structure.

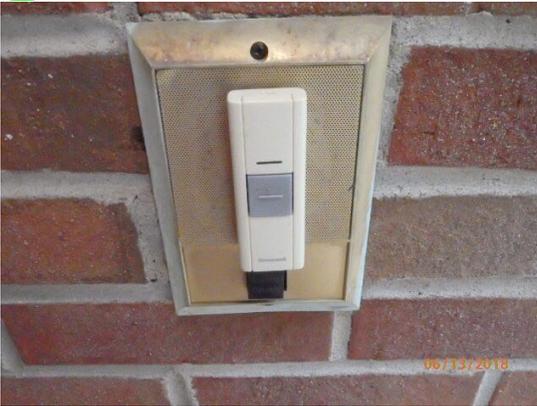
**REPR 19:** - The door bell did not function when tested. Repair as needed.

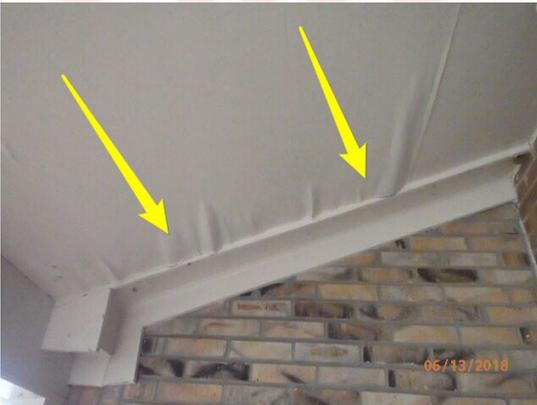
**REPR 21:** - Water damage with elevated moisture levels were noted in the entry stoop ceiling that is believed to be caused from the missing flashing on the roof above. UltraSound recommends further investigation and repair by a qualified professional.

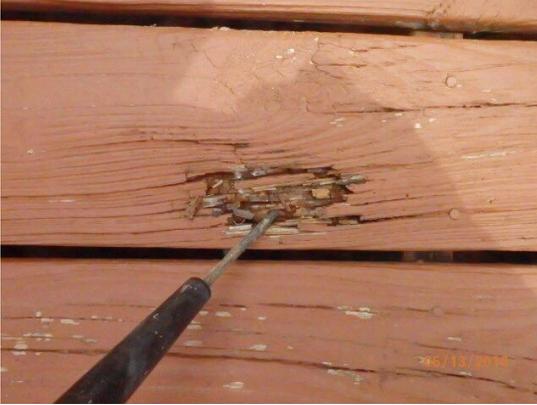
Patio floor

**REPR 25:** - Wood decay was found in portions of the wood floor decking that has progressed to the point that replacement of at least part of the materials is needed. The deck should be further inspected by a professional deck contractor and the necessary repairs made.

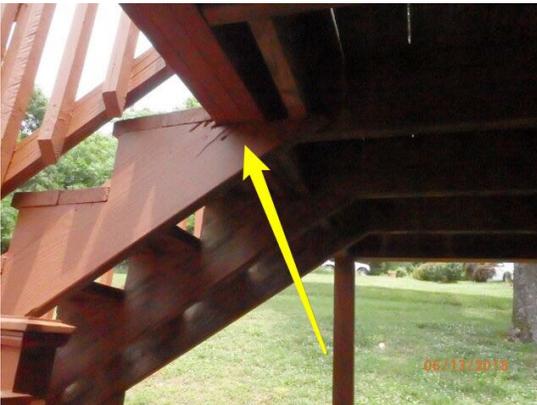
**SAFT 29:** - The stringers on the rear patio stairway do not have the sufficient bearing surface contact that is needed for them to be properly supported to the outer portion of the deck. Additional supports are needed for them to be used in a safe condition. Repairs are needed by a qualified professional. Safety issue.

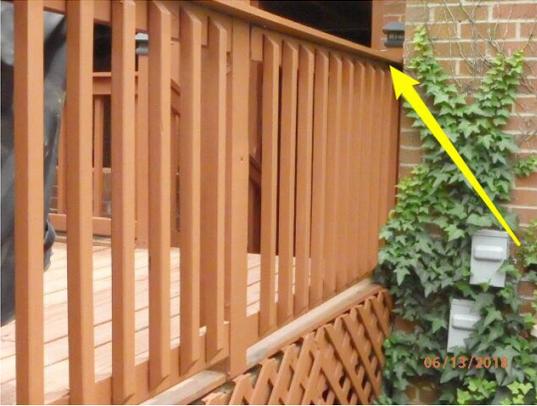
**REPR 30:** - A loose handrail(s) was noted on a portion(s) of the deck. The rail should be secured to ensure safety.

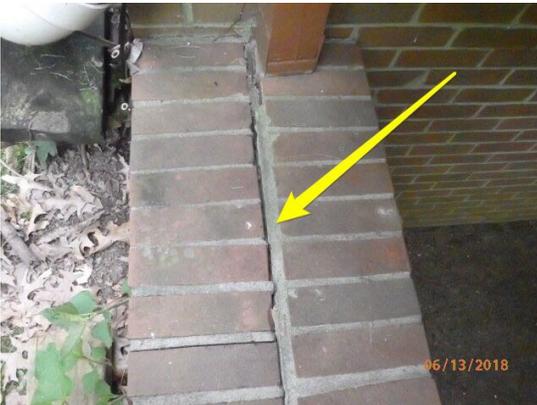
**REPR 35:** - The retaining wall requires some repair/tuck pointing in the upper mortar joints to help prevent moisture from penetrating the wall causing freeze damage.

Needs tuck pointed

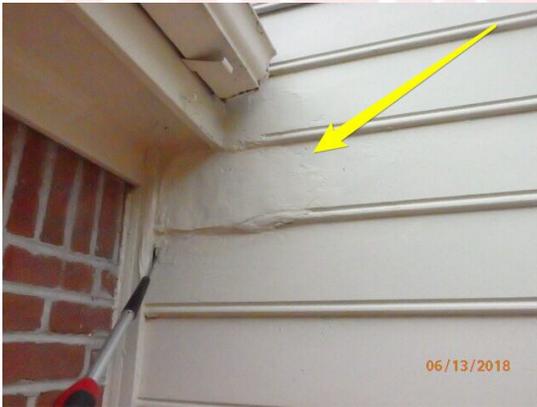
Off of rear patio

**REPR 46:** - Decay was noted to portions of the siding at the rear, front, and left end of the structure. The exterior siding on the structure appears to be made of masonite. Some of the end joints and seams are soft, which is the result of moisture that has penetrated these areas. This type of siding requires routine maintenance and should be kept caulked and painted. The siding should be further inspected and the necessary repairs made.

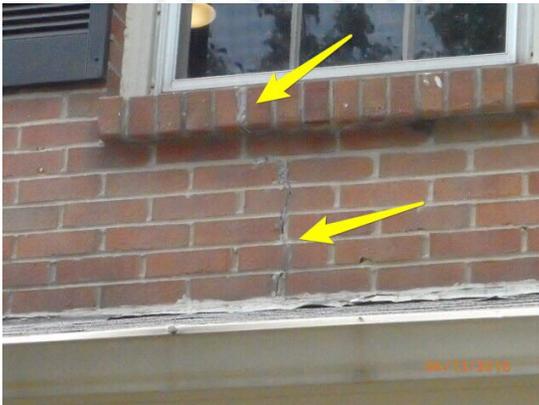
**REPR 47:** - A crack(s) was noted in the masonry veneer wall on the front of the building that is significant enough to warrant further by a qualified professional.

Crack below upstairs window & is approximately 1/4" wide

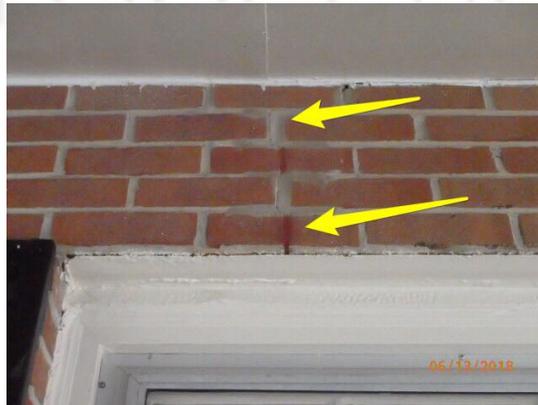
Repaired crack above downstairs window

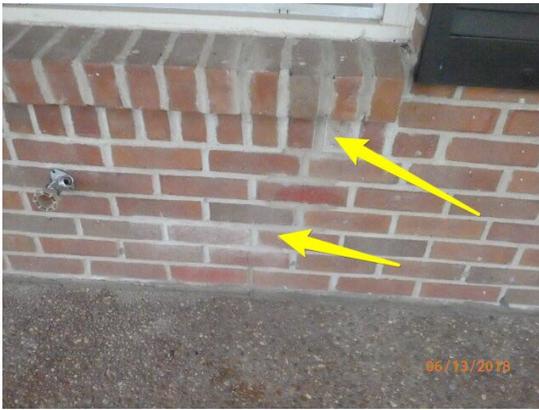
Repaired crack below downstairs window

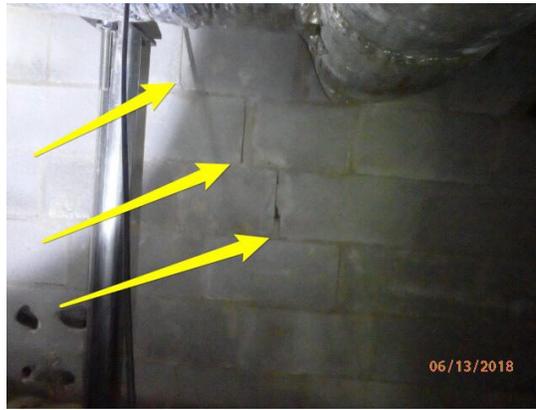
Crack in foundation wall below entry stoop

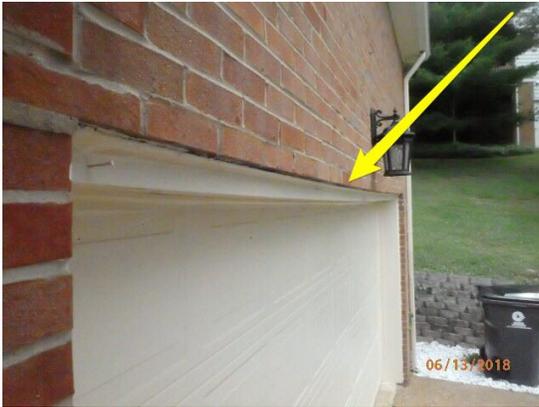
**REPR 48:** - Sagging was noted in the masonry wall above the garage door opening that appears to be the result of the brick lintel above the door not being properly attached to the framing components. Consideration should be given to having it repaired.

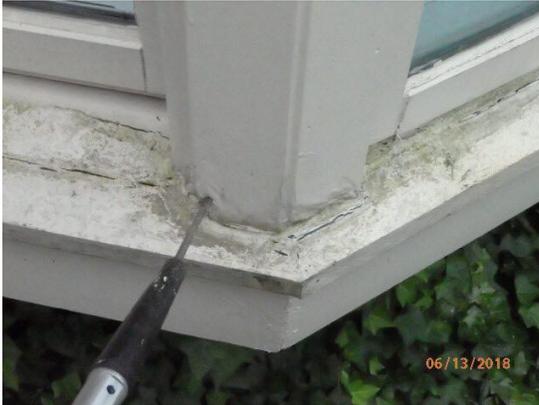
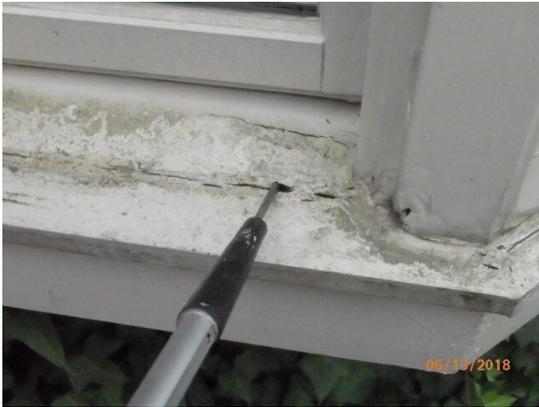
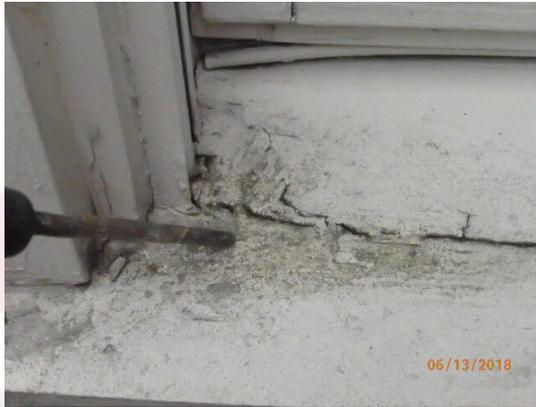
**REPR 54:** - Decay was noted in a portion(s) of the window(s) on the rear of the building. This condition will eventually allow rain water to penetrate the inner walls of the structure causing further damage. Repair/Replace.

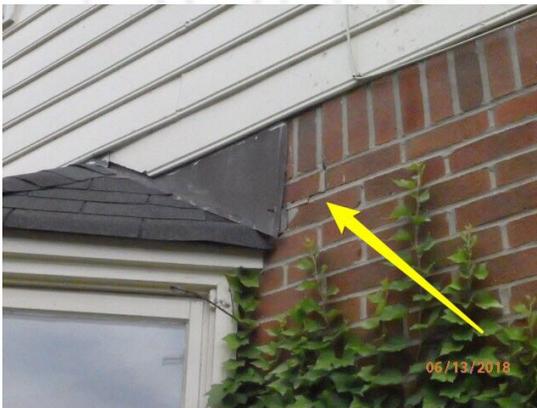
**68:** - Cracks were noted in the brick wall on the rear of the building around the flashing above the bay window that needs to be sealed/repared.

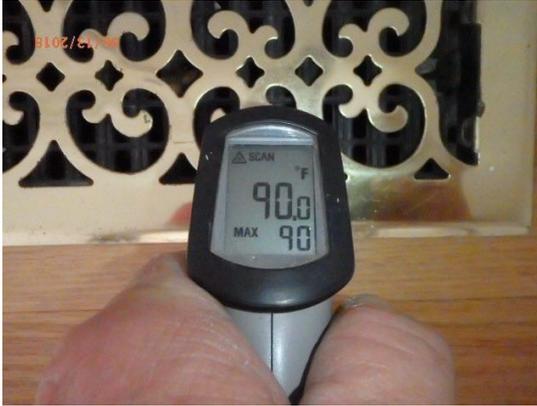
**REC 101:** - The electric heating unit is approximately 21 years old and appears to be nearing the end of its life expectancy. UltraSound recommends further inspection by a qualified HVAC contractor prior to closing to determine operation and safety condition. The internal components were not assessed as disassembly and invasive testing is beyond the scope of the inspection and not permitted by the TN standards of practice.

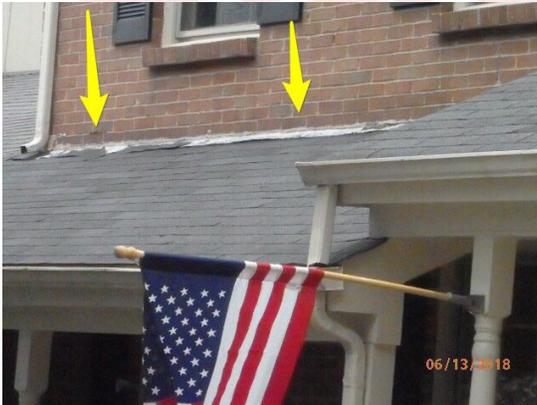
**137:** - No counter flashing was found installed on any of the structure where the roofing shingles intersect with the brick siding. This should be installed to prevent moisture from penetrating behind the counter flashing that is present and into the structure.

Flashing in poor condition believed to be responsible for front porch leak

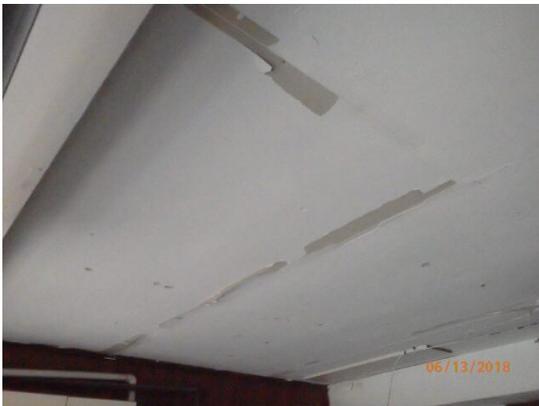
**REPR** 162: - FYI - Cracks were noted in portions of the tape joints in the sheetrock ceiling that are commonly seen by the inspector. This is usually due to shrinkage in the building materials or slight movement in the framing components. Repair as needed.

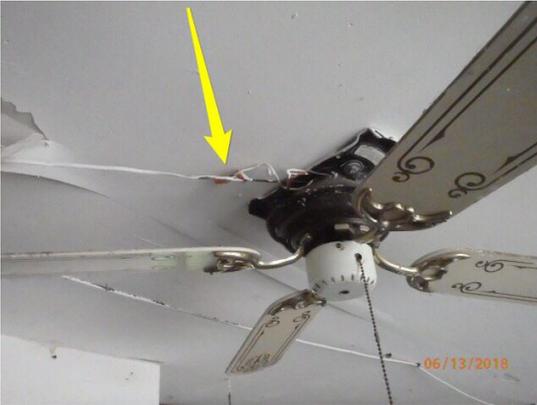
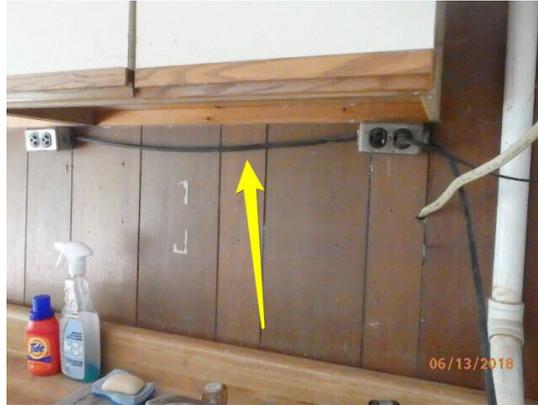
**163:** - Unprofessional wiring was noted in the garage that is in need of repair/corrected by a qualified professional.

Non permanently installed outlets

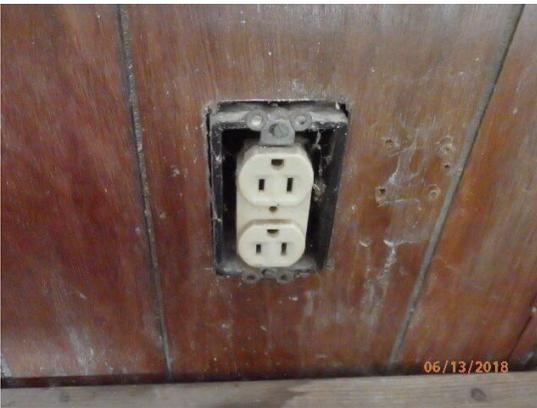
Missing cover plate

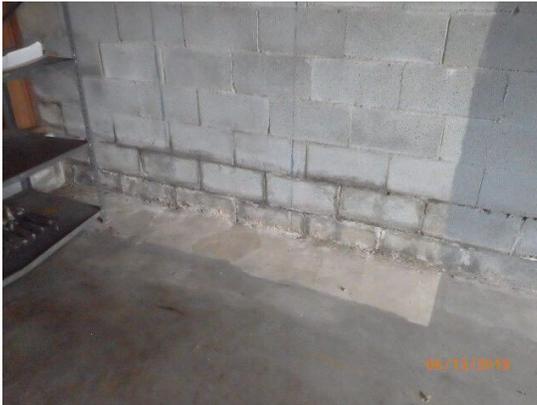
**SAFT 166:** - Elevated moisture levels were measured in the right front garage wall. Corrections should be made to the water drainage on the front side of the house to help resolve this issue.

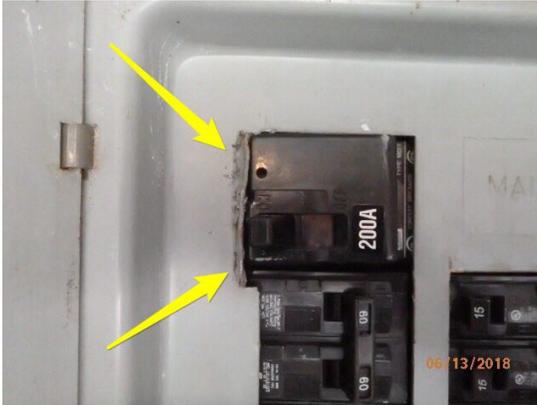
**SAFT 173:** - The dead front cover panel has been modified to allow clearance for the main breaker which is not allowed by the manufacture of the panel. UltraSound recommends further investigation and repair by a qualified professional.

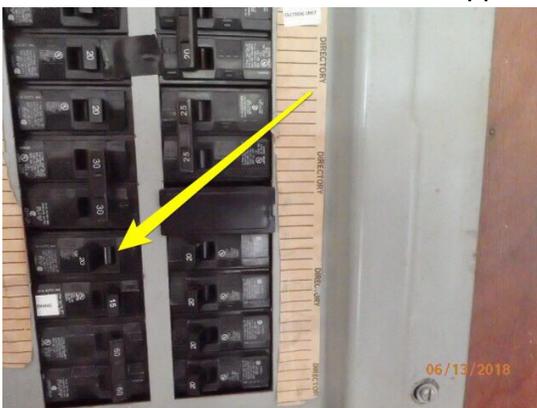
**177:** - Circuit breakers were found in the off position at the arrival of the inspection. It was undetermined if there is an issue with the circuit or appliance they control and further investigation is needed.

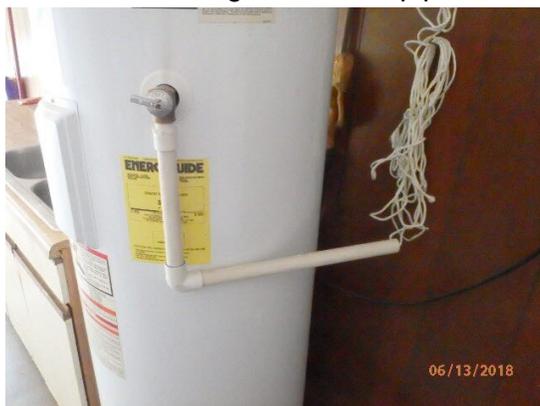
**SAFT REPR 197:** - The overflow discharge pipe for the water heater is made from of PVC plastic which is not acceptable by today's safety standard. The pipe should be replaced with copper or a pipe that can withstand 200 degrees F. The pipe should also extend to within 6 inches of the floor.

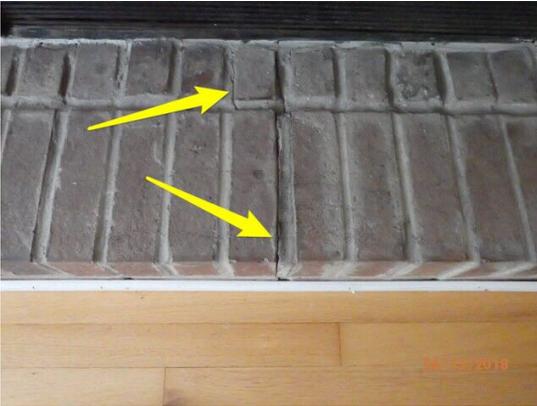
**REPR 209:** - FYI - A crack was noted in the fireplace hearth. For cosmetic reasons, it can be replaced as needed.

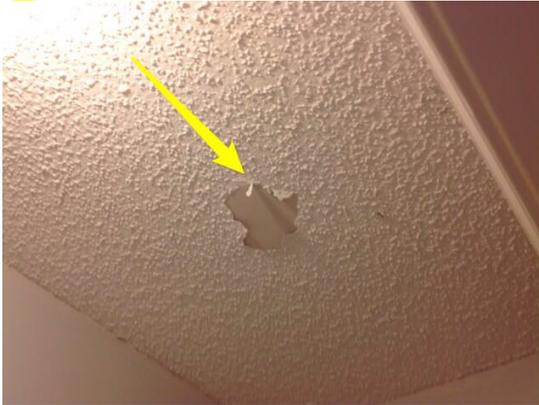
Laundry room ceiling

**FYI 234:** - Damage was found in the ceiling of this room that is in need of repair.

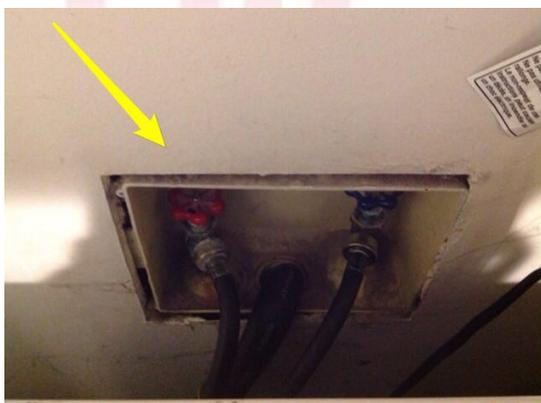
**FYI 241:** - The trim ring was found missing from the washing machine connection box that needs to be installed.

Missing trim ring

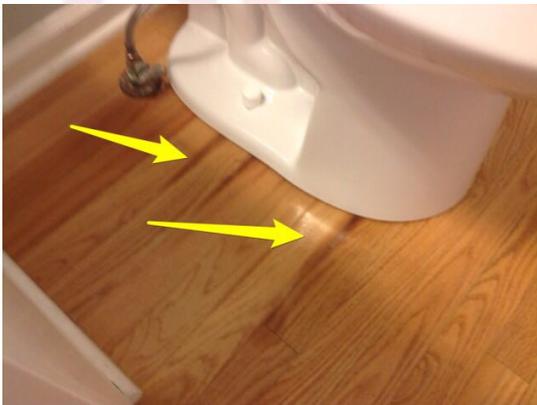
Powder room

**REPR 249:** - Water stains were noted in the hardwood floor around the toilet which indicates a possible leak issue. No elevated moisture levels were measured at the time of the inspection, however, further investigation is needed.

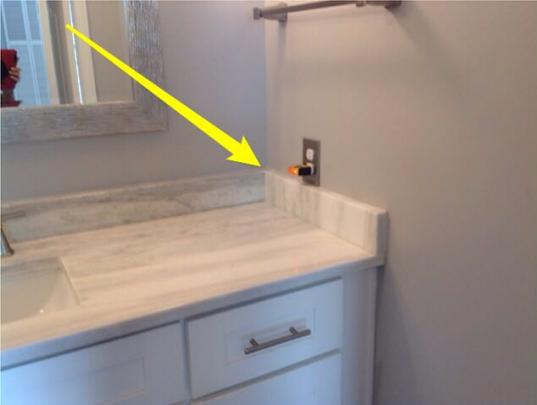
**SAFT 251:** - There is a Ground Fault Circuit Interrupt (GFCI) outlet installed in the area of the sink however it failed to stop the current flow or did not reset as designed after testing. This is a safety issue and replacement or repairs are needed.

The outlet right of the master sink is not GFCI protected

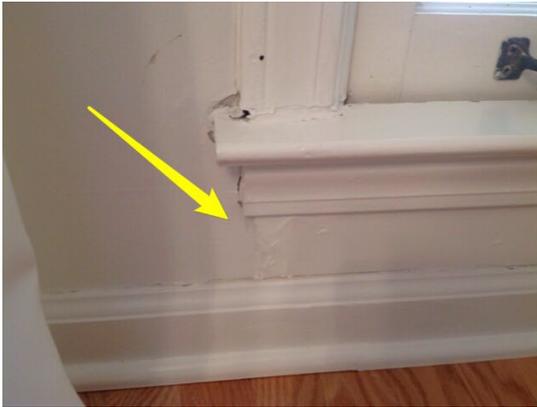
Right window in left front living room

**REPR 277:** - A poor wall repair was found in the wall below the right window in left front living room. The reason for the repair is unknowns and further attention is needed for a better appearance.

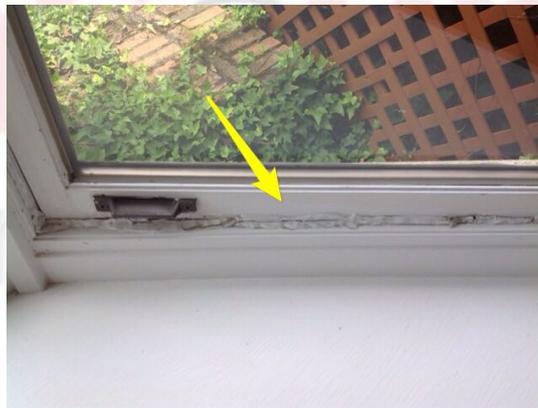
**283:** - The windows in these rooms are stuck in the closed position not allowing the inspector to open and inspect the window. Repairs are needed for it to function as designed.

The rear windows in the rear family room

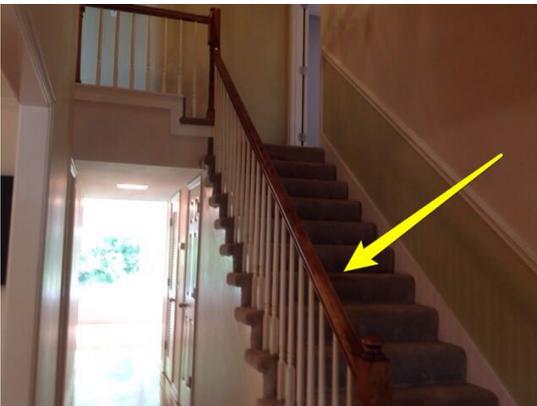
**SAFT** 291: - The handrail on the main stairway is loose where it attaches to the wall and needs repaired. Safety issue.

Loose handrail

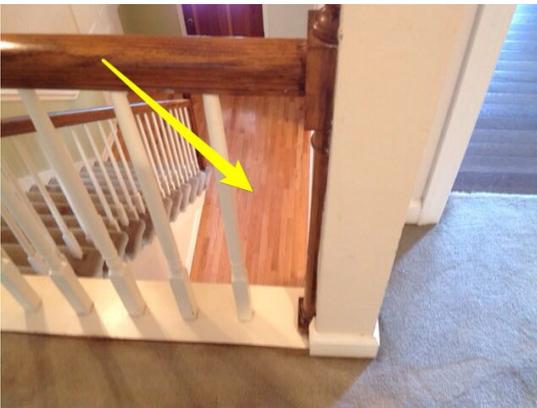
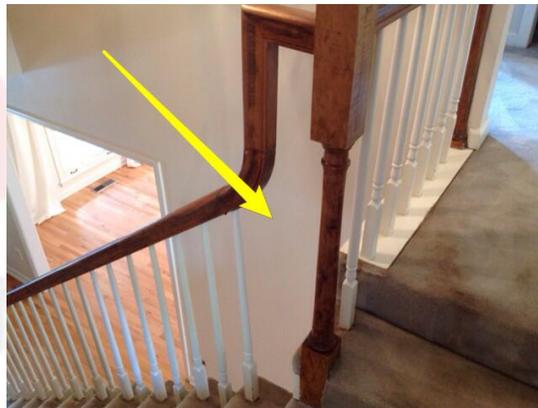
**SAFT 293:** - The balusters on the upper portion of the stairway are installed too far apart leaving an unsafe condition for small infants. Per minimum safety standards, the balusters spacing should not exceed 4". Although the structure may predate this requirement, for safety reason consideration should be given to having this corrected.

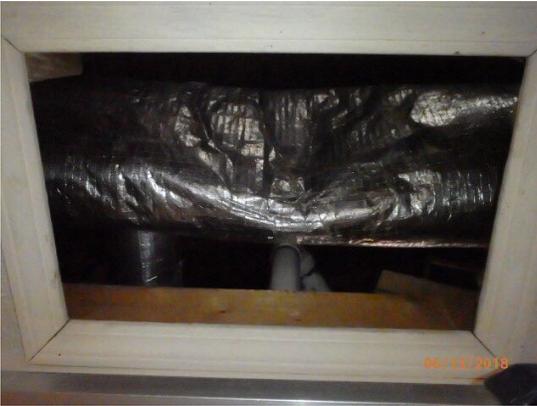
**301:** - A section of HVAC duct has been installed across the attic access hole in the upper attic which has made it not accessible to view and inspect. UltraSound recommends having another access panel door installed to allow access to the attic which contains important roofing framing components that should be inspected prior to closing.

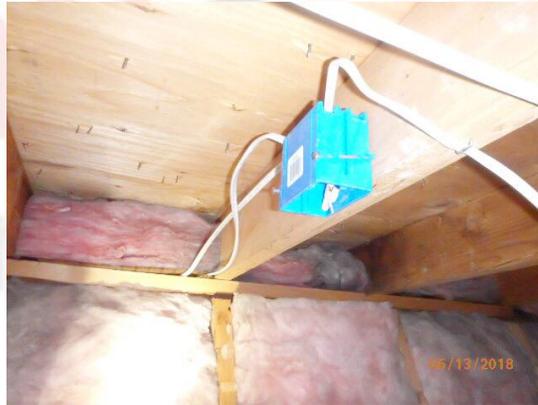
**302:** - Unprofessional electrical wiring was found in the attic closet off of the bonus room that needs further inspected and the necessary repairs made by a qualified electrician.

Missing cover plate

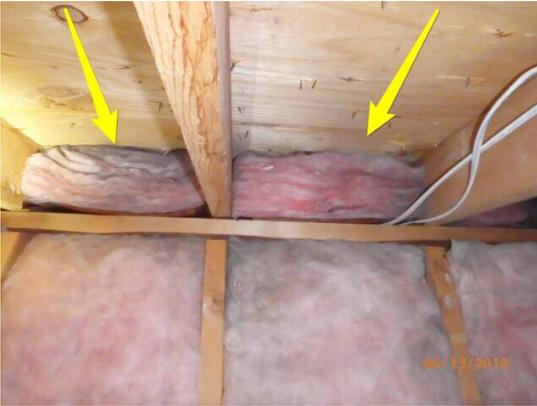
**303:** - Insulation was found in contact with the roof's sheathing in the walk-in attic off of the bonus room. There should be at least a 1 1/2" air gap between the insulation and the roof sheathing for proper attic ventilation and to help protect the roof decking from condensation. Either the insulation should be repositioned or styrofoam baffles be installed that are designed for this type of application.

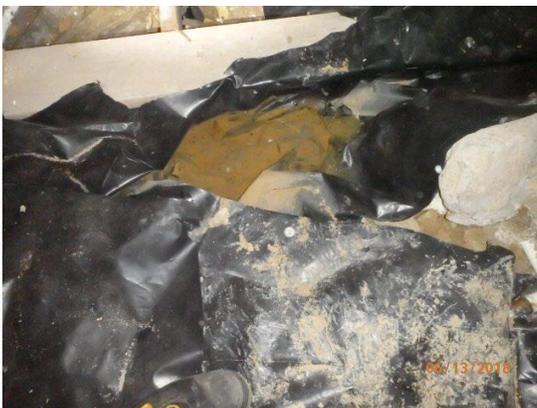
**REPR 315:** - Water was found accumulated in the crawlspace floor under the left rear portion of the building. It was undetermined where exactly the water came from however it should be further investigated and removed from the building. In addition, keeping the gutters clean, extending gutter downspouts to at least 4' to 6' from the foundation and correcting the ground slope around the structure should help address a lot of this issue..

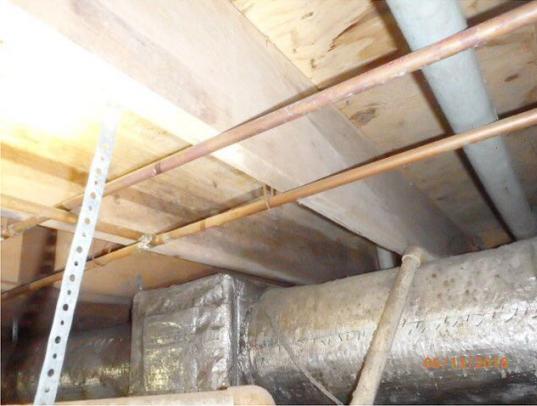
**SAFT 316:** - A light amount of microbial debris was noted on the floor joists in the crawlspace. Certain types of microbial debris can be toxic to humans. UltraSound inspectors do not inspect for mold nor are we microbial debris experts, we only note that it is present as a courtesy. We recommend that these areas be further investigated by a professional remediation company prior to closing to determine if remediation is necessary. Possible health issue.

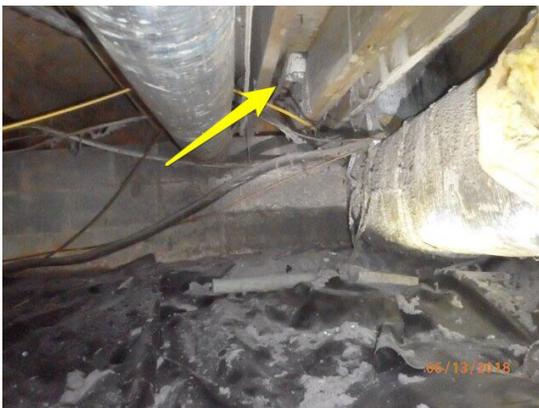
**SAFT REPR 321:** - The dryer ventilation pipe is currently exhausting unwanted lint and moisture into the crawlspace. The inspector recommends installing a nonflexible metal dryer vent pipe in as straight and as short of distance as possible to the exterior of the house with a louvered vent door attached to the end.

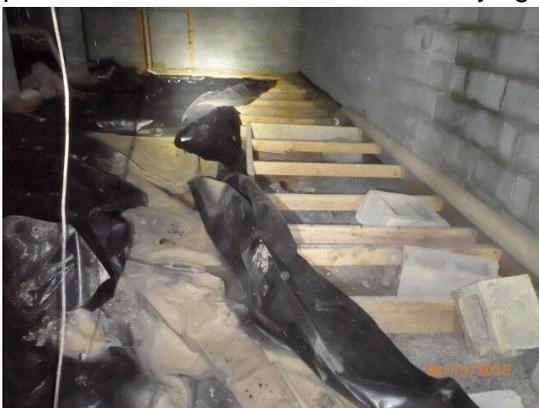
**REPR 322:** - Wood scraps were found under the house in the crawlspace that needs removed. The inspector highly recommends removing all wood or paper products from the crawlspace floor to help prevent the attraction of wood destroying organisms.

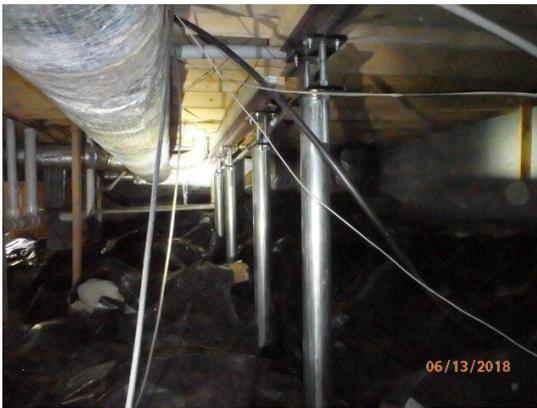
**FYI 327:** - Additional supporting piers have been installed in the crawlspace under what appears to be a load bearing wall by a professional foundation contractor for some unknown reason. Recommend further investigation to determine why the piers were installed and if the work carries a transferable warranty.

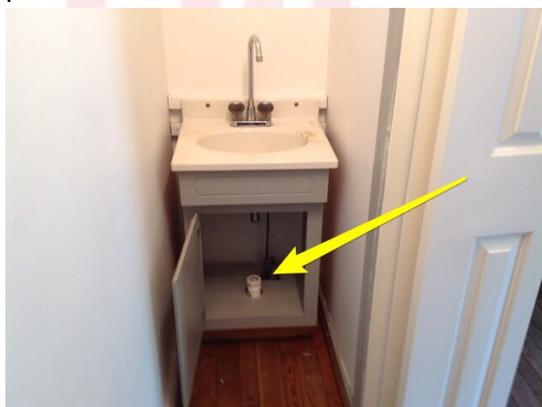
**REPR 340:** - Unprofessional plumbing has been performed in the upstairs bonus room closet where a sink has been installed. The drain assembly has become disconnected from the sink that is currently draining into the garage lavatory. UltraSound recommends further investigation and repair by a qualified professional.

Disconnected drain pipe
