# UltraSound

### Confidential Inspection Report

123 Sample Street  
Hompson's Station, TN 37179

Monday, February 26, 2018

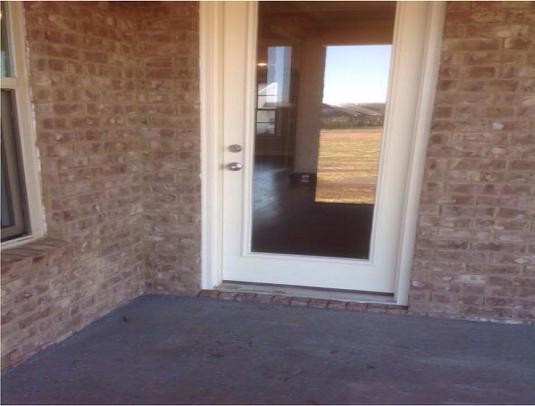
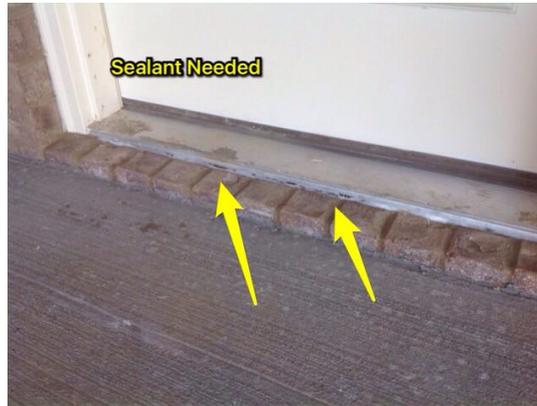
**25:** - Caulk/sealant is needed on the threshold at the patio door to be more energy efficient.

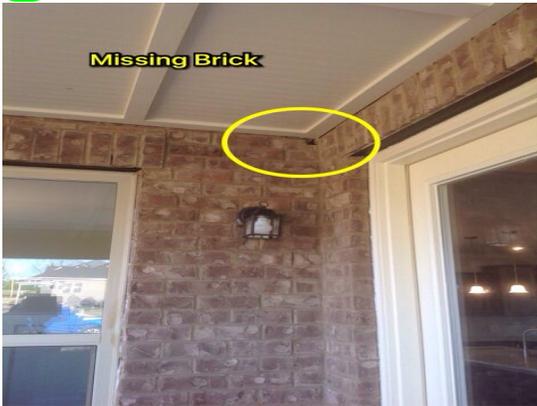
48: - Missing section of brick was noted at the rear patio door leaving a gap in the siding.

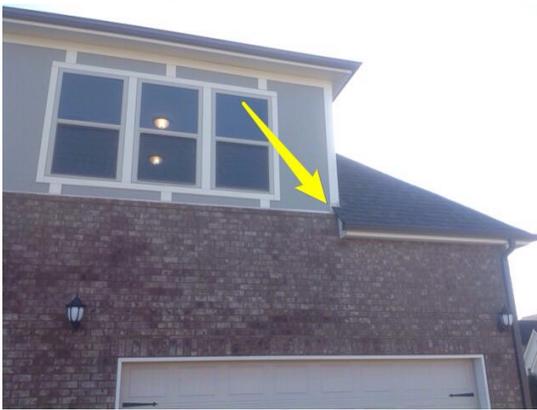
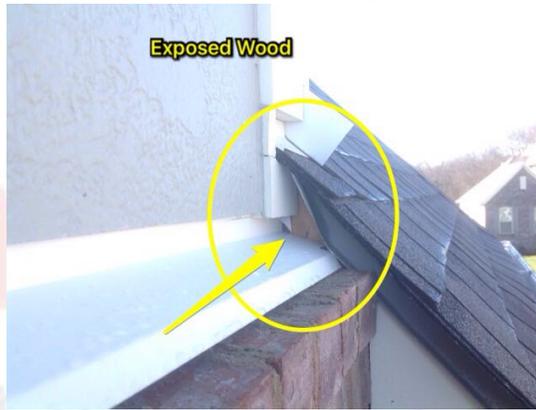
49: - Missing siding and/or trim was noted at the bay of windows above the garage, leaving a section of the framing members exposed. Repairs are needed to insure a water tight seal.

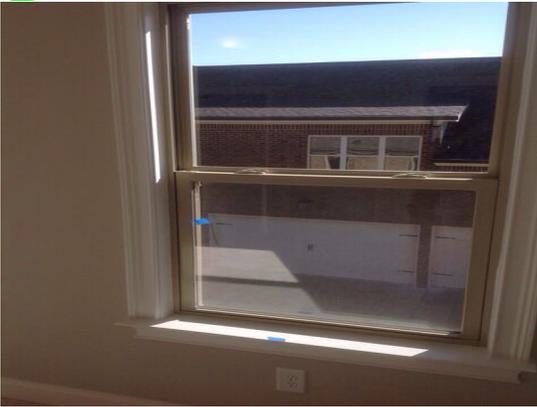
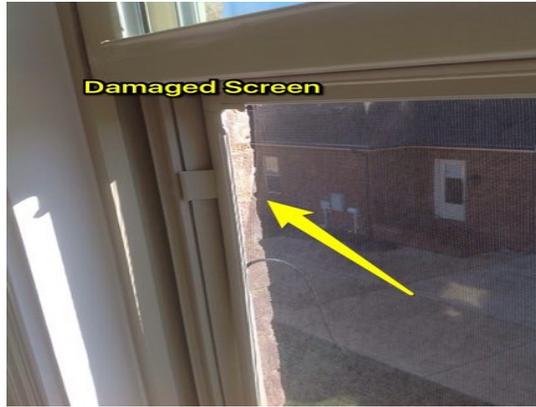
56: - The screen at the upstairs bedroom window is damaged and in need of repair.

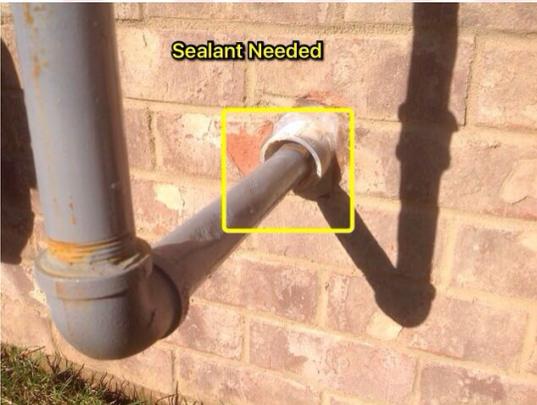
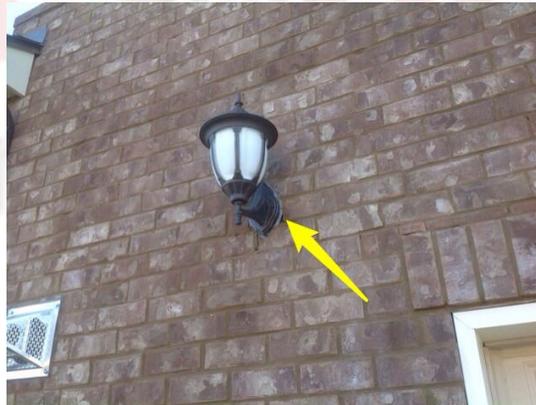
58: - Missing/shrinking caulk was noted at pipe/wiring penetration holes on the right side(s) of the home at the gas line penetration and the left side at the garage lights. All areas where mechanical pipe and wiring enter the structure should be sealed to prevent small animals and moisture penetration.

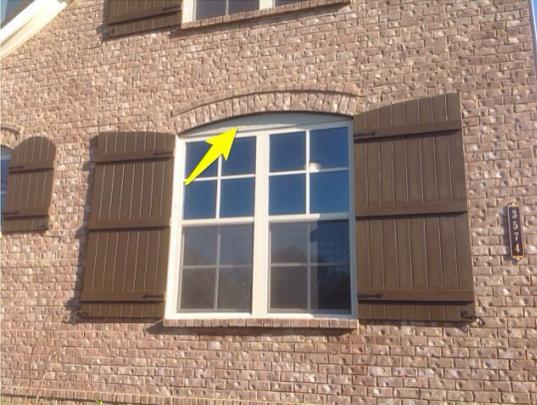
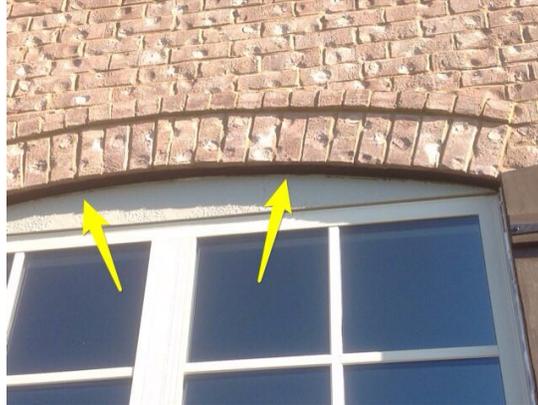
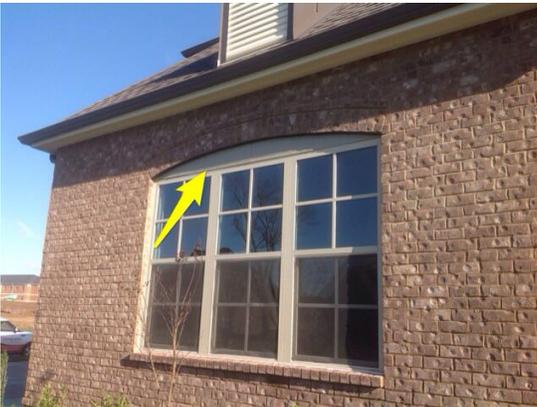
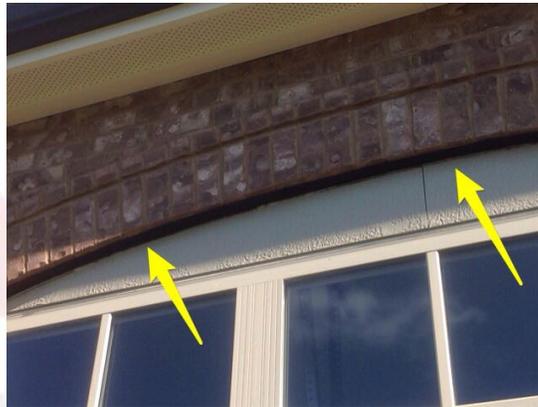
**REPR 59:** - Missing/shrinking caulk was noted at several of the window(s) around the structure. The perimeter and all gaps around windows should be thoroughly caulked to prevent moisture penetration and damage to the inner wall.

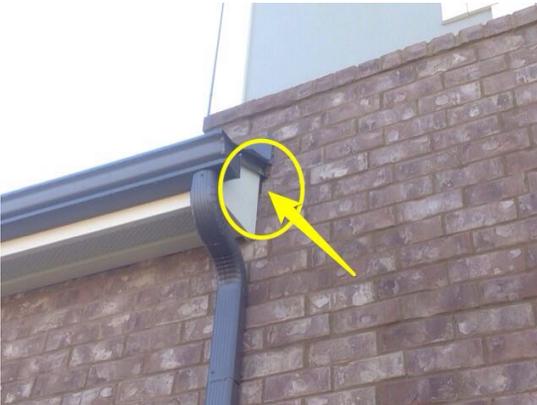
**REPR 60:** - Mortar/sealant is needed where the brick veneer and trim siding intersect above the garage door opening. This is to insure a water tight seal.

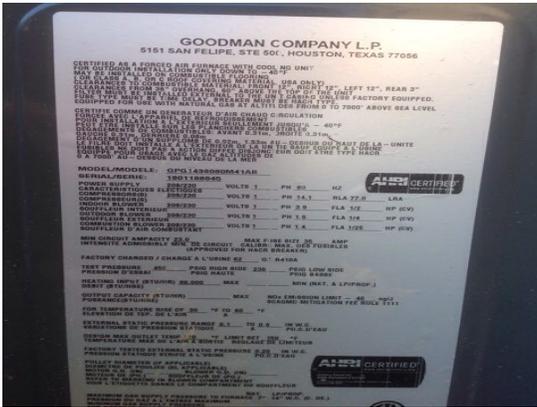
**REC 86:** - The outside temperature was below 65 degrees, preventing the testing of the AC unit. Most manufacturers instructions recommend not operating the system at temperatures below 65 degrees due to possibility of damaging the compressor. UltraSound recommends further evaluation by a qualified professional prior to closing. The average life of this component is approximately 15 to 20 years assuming normal maintenance is performed per mfg.

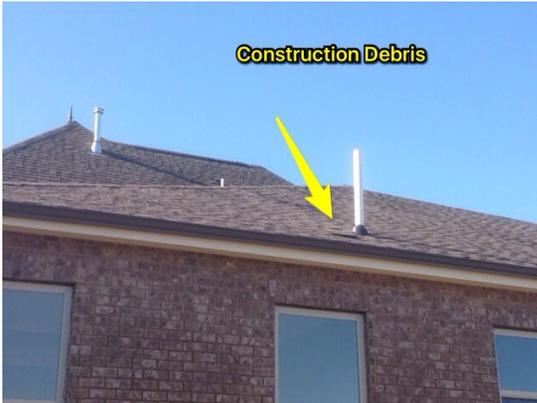
**REC 161:** - A small amount of Construction debris was noted on the roof along the rear of the home. Recommend having the debris removed.

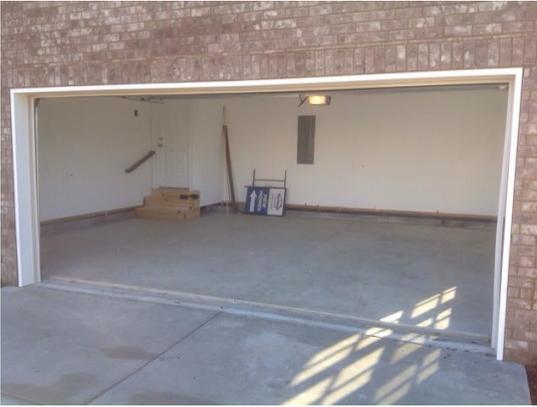
**SAFT 166:** - The garage door opener currently requires greater resistance to reverse the direction of the door when closing than is needed to be operated in a safe condition. Adjustment are needed to the "downward force" screw behind the light cover lens on the door opener to reduce this force. See owner's manual for proper setting. Safety issue. (FYI - Some Genie brand door openers do not have an adjustment screw to adjust this tension).

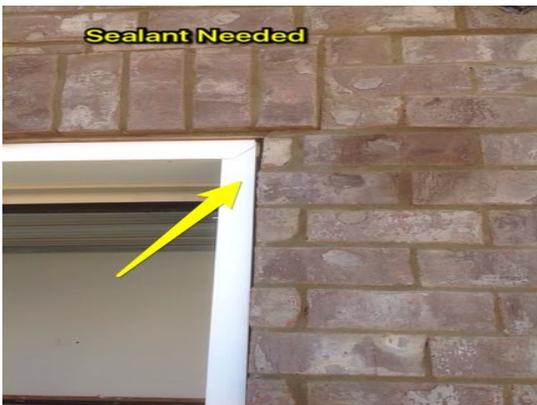
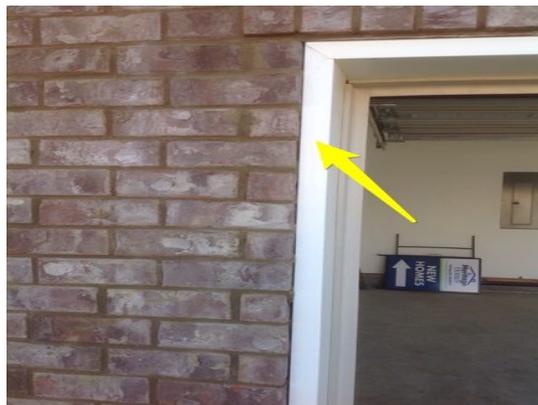
**REC 170:** - The metal trim that surrounds the garage door jamb needs caulked and sealed where it intersects with the brick to prevent moisture from penetrating the area causing decay 2x framing members.

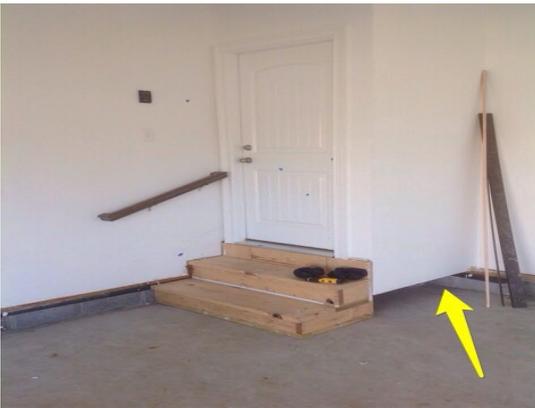
**REPR** 174: - The interior wall of the garage does not properly enclose the space under the garage entry landing area causing a breach in the required Fire wall separation. Recommend having the issue repaired so that the living space has the required Fire separation from the garage area.

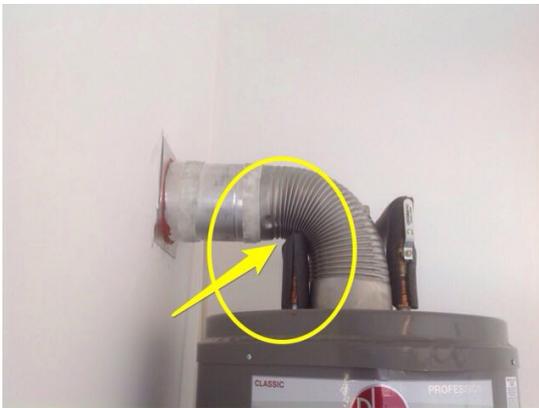
**SAFT 214:** - The flue exhaust pipe for the water heater is in contact with flammable material creating an unsafe condition. The pipe should have at least 1" clearance from any combustibile material to be in a safe condition and to meet today's minimum safety standards.

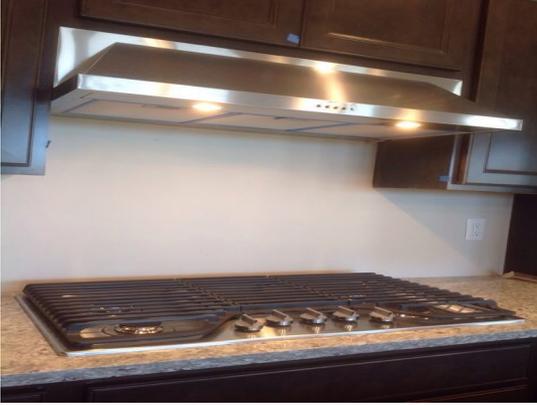
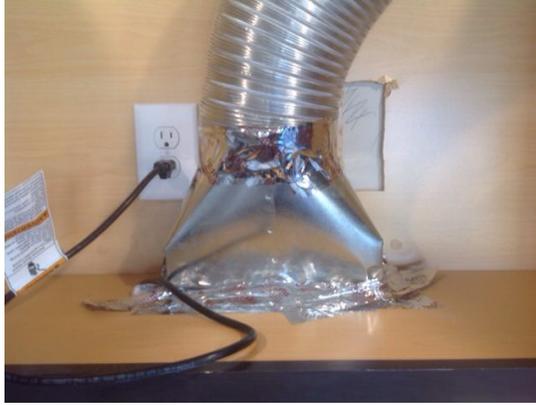
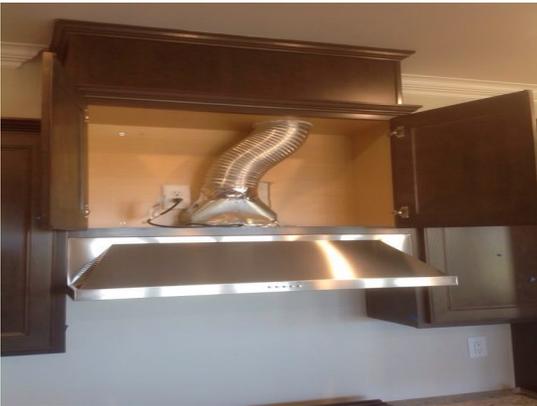
**REPR 258:** - With the inspection of the vent hood it was found that the vent hood is not properly connected/sealed where it connects to the vent piping. This is allowing the vent hood to partially exhaust out through the front of the unit between it and the cabinetry. Repairs are needed so that the vent hood fully exhaust out through the vent piping as designed.

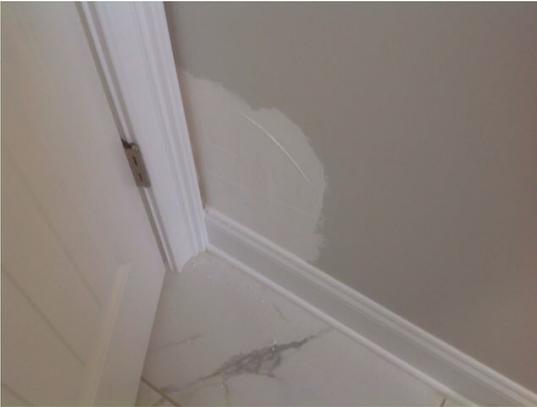
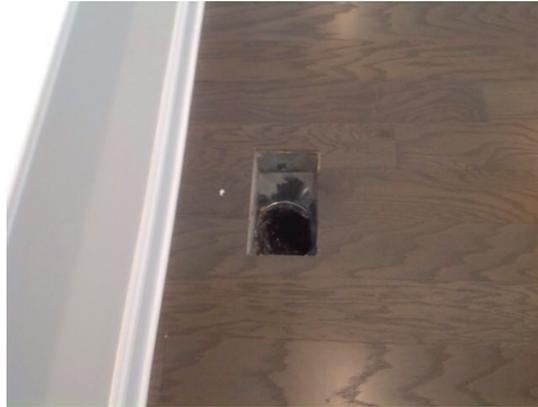
**REC 328:** - The house was noted to be in the "punch list" phase of new construction. During this phase of construction many items may still be in the process of completion but are not mentioned individually in this inspection report. This common items include but are not limited to; unfinished portions of drywall, missing outlet covers, unfinished caulking, uninstalled components, missing light bulbs, and other small misc repair items. In a new construction home, the buyer and agent is encouraged to do a "blue tape" walk through with the builder to note any items of concern.

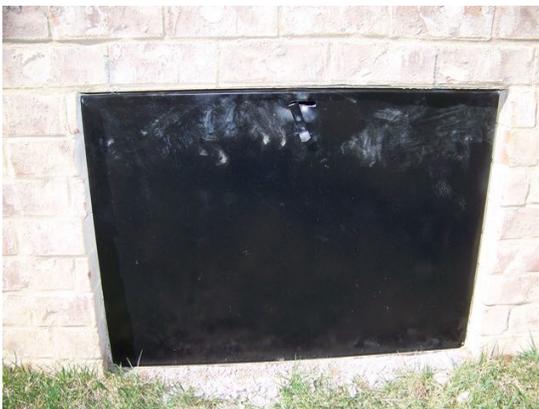
**REPR 349:** - The crawlspace door needs some adjustment/repair for it to fully close which is needed to prevent small animals and rodents from entering the structure.

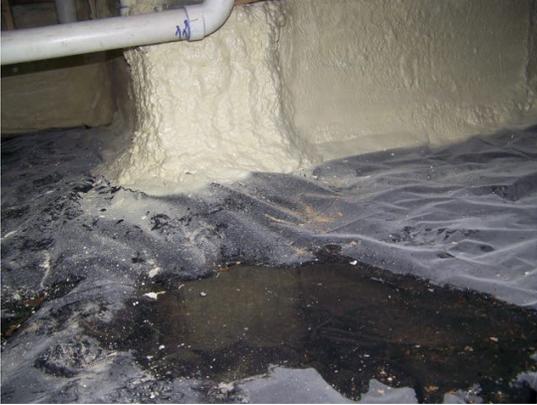
**REC 358:** - Small areas of pooling water were noted in the crawlspace that is believed to be from a previous leak during the construction process. No leaks were noted in the plumbing system and it is recommended to have the water dried up.

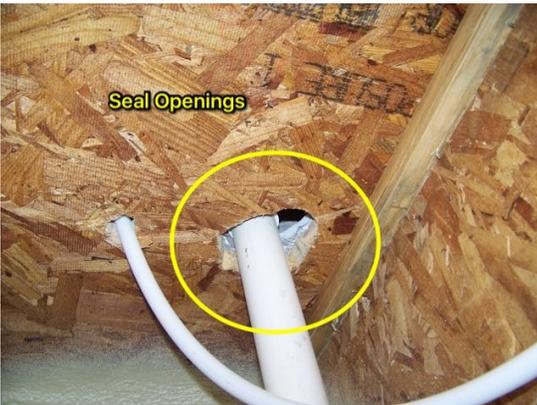
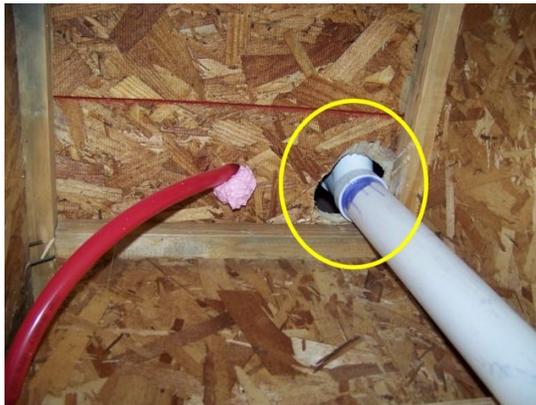
**REPR 363:** - A large opening was found in the subfloor under the master tub and hall tub that needs repaired to help prevent small animals and rodents from entering the structure.

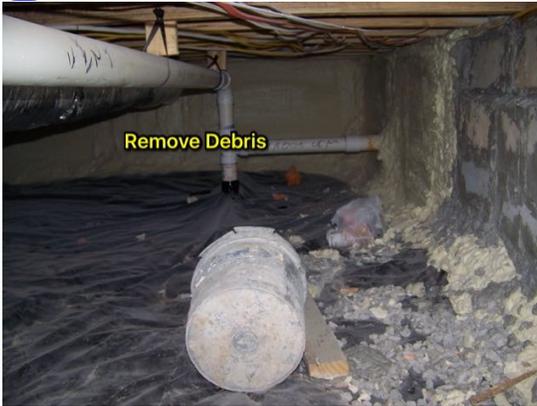
**REC 370:** - A light amount of Debris was found in the crawlspace that should be removed.
