# UltraSound

### Confidential Inspection Report

123 Sample Street  
Brentwood, TN 37027

Wednesday, June 13, 2018

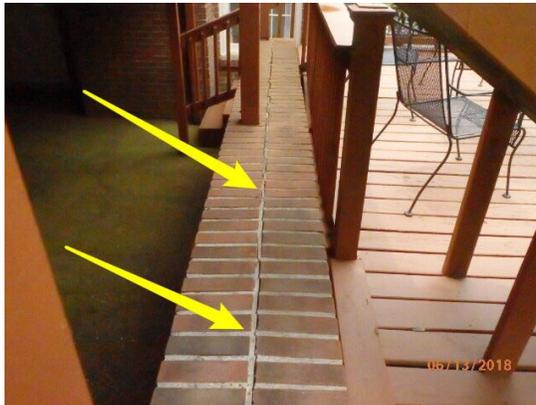
**REPR 35:** - The retaining wall requires some repair/tuck pointing in the upper mortar joints to help prevent moisture from penetrating the wall causing freeze damage.

Needs tuck pointed

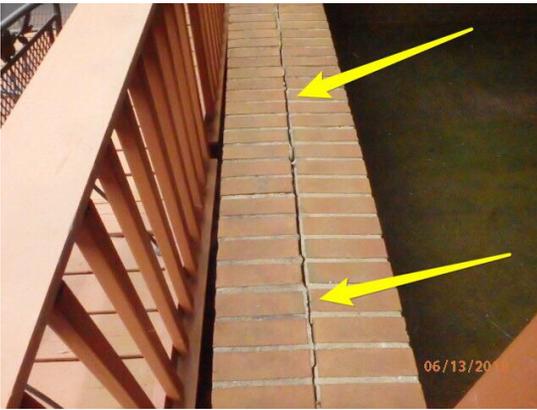
Needs tuck pointed

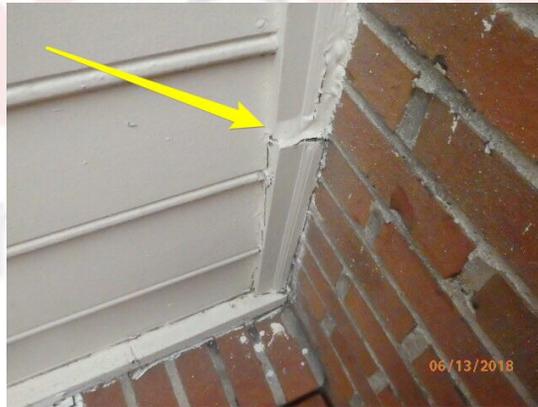
Off of rear patio

**REPR 46:** - Decay was noted to portions of the siding at the rear, front, and left end of the structure. The exterior siding on the structure appears to be made of masonite. Some of the end joints and seams are soft, which is the result of moisture that has penetrated these areas. This type of siding requires routine maintenance and should be kept caulked and painted. The siding should be further inspected and the necessary repairs made.

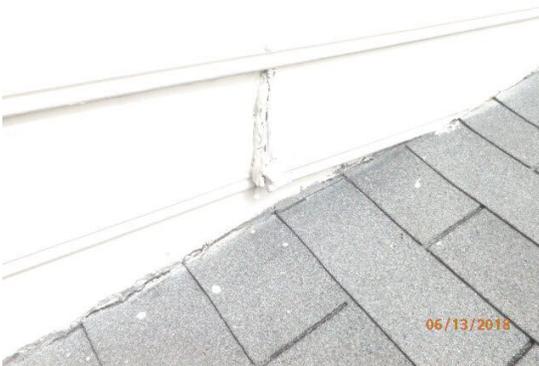
Swelled end left end of house

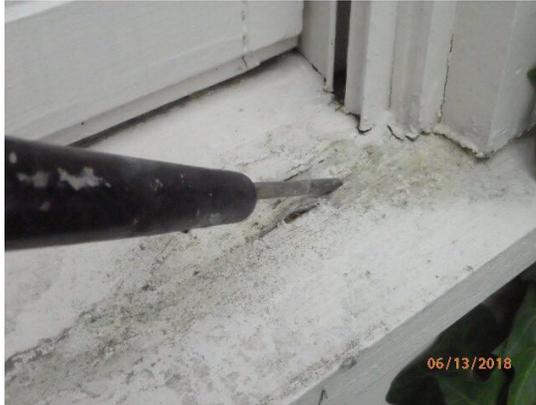
**REPR 54:** - Decay was noted in a portion(s) of the window(s) on the rear of the building. This condition will eventually allow rain water to penetrate the inner walls of the structure causing further damage. Repair/Replace.

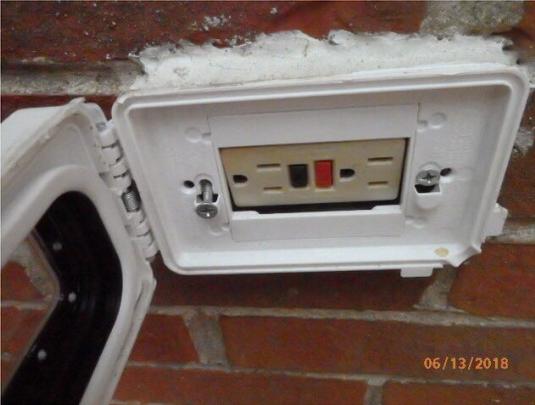
**SAFT** **REPR** **57:** - A defective or incorrectly wired GFCI electrical outlet(s) was noted on the rear patio off of the bonus room, creating a safety issue. The cover plate is also loose and needs properly attached. Repair/Replace

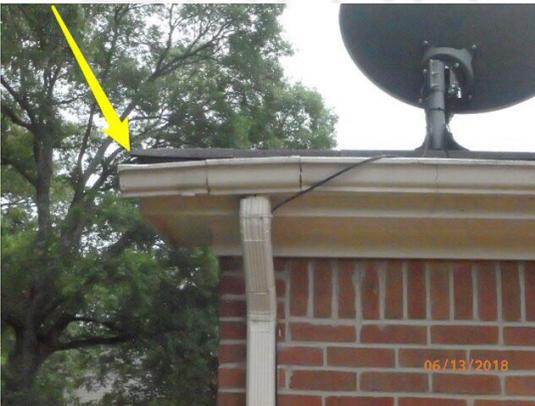
**REPR** **59:** - An insufficiently sloped gutter(s) was noted on the rear of the structure, This condition prevents water from properly channeling away from the structure, which can negatively impact the fascia, soffit, crawlspace, and foundation. Gutters should be examined and cleaned regularly to promote the free flow of water.

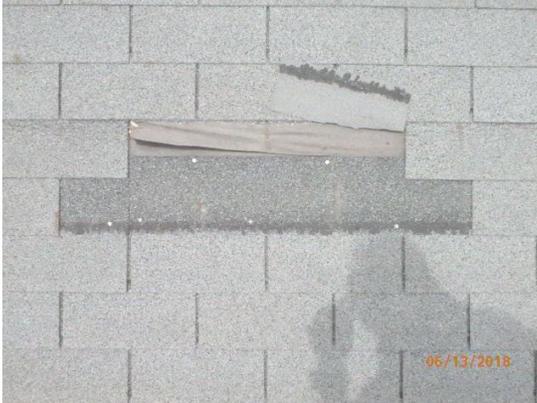
**REPR 135:** - A missing shingle(s) was noted on the front portion of the roof. This condition can exposing nail heads on shingle and adjacent flashing, resulting in possible roof leaks. UltraSound recommends further investigation and repair by a qualified professional.

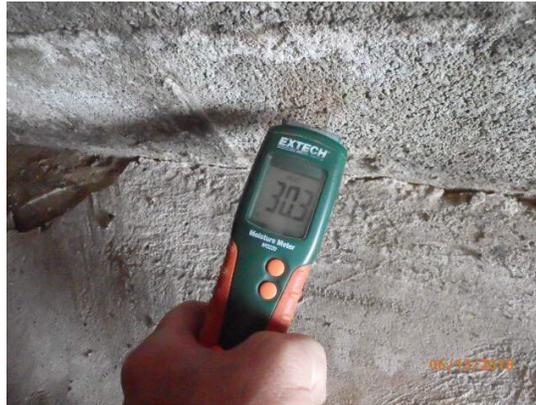
**SAFT 166:** - Elevated moisture levels were measured in the right front garage wall. Corrections should be made to the water drainage on the front side of the house to help resolve this issue.

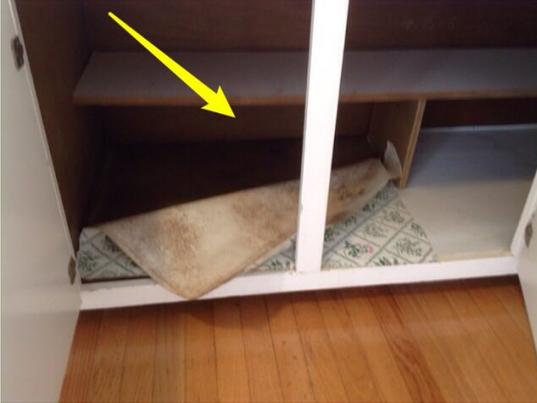
Lower cabinet right of sink

**REPR 214:** - FYI - The floor of the base cabinet right of the sink is sagging from what appears to be water damage. No active leaks were found during the inspection and the extent of the damage was undetermined. The area should be monitored for future leaks and repairs may be necessary to the cabinet floor.

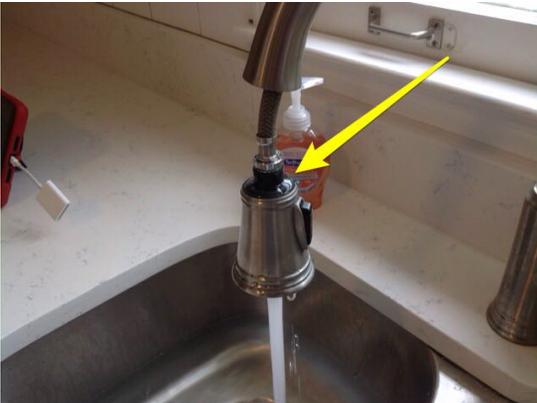
**REPR 217:** - The dish sprayer attachment leaked around the base of the sprayer when tested. The sprayer attachment will need repaired/replaced to function as designed.

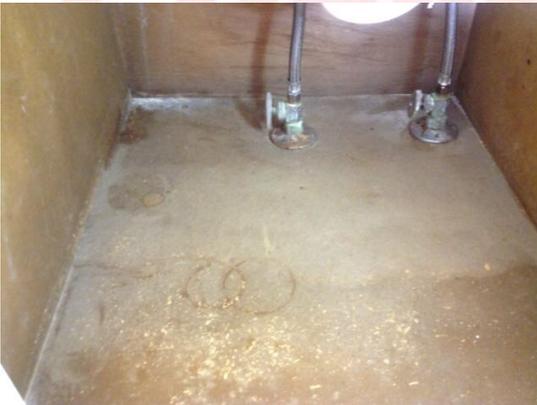
Powder room cabinet

**FYI 252:** - The base of the vanity cabinet under the sink has previously been wet and show signs of slight water damage. No elevated moisture levels were measured at the time of the inspection and the plumbing system should be monitored for any future leak issues.

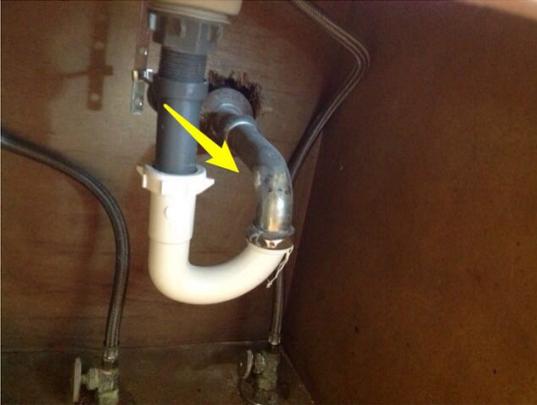
Powder room

**FYI 254:** - Corrosion was found on the plumbing drain pipes indicating they are reaching their life expectancy. It did not appear to be leaking during the inspection however consideration should be given to having the pipes replaced with PVC.

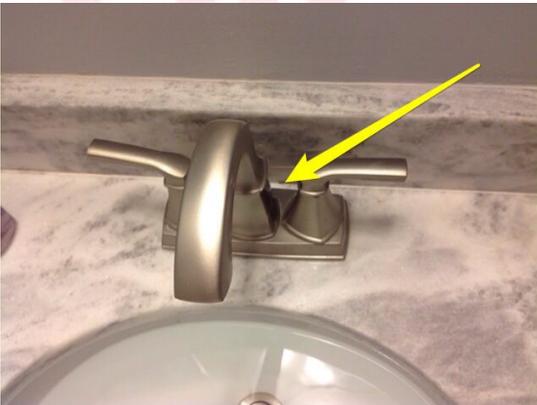
**REPR 255:** - The faucet is loose where it attaches to the base of the sink/cabinet. Repairs are needed to have it properly secured.

Powder room faucet loose

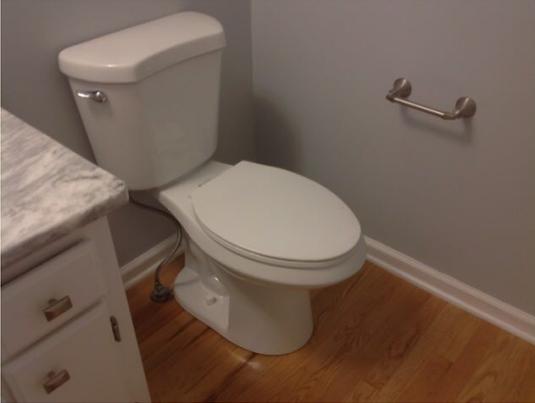
Powder room toilet

**REPR 256:** - A loose toilet was noted in the bathroom mentioned below. UltraSound recommends further investigation and repair by a qualified professional.

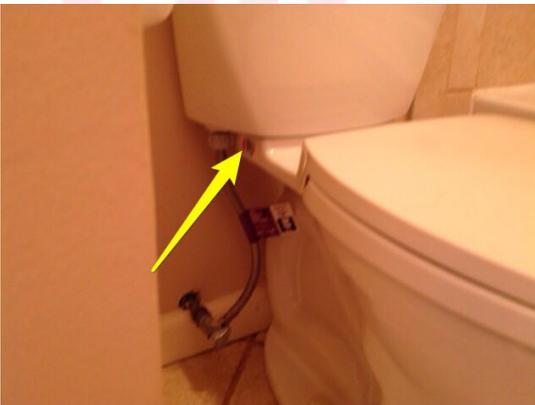
**REPR 257:** - An active leak was found between the upper tank and the toilet bowl that is in need of repair by a qualified professional.

Leaking at both sides of the toilet

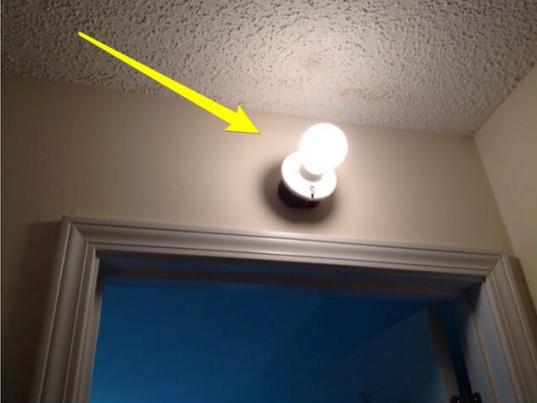
Rear center bedroom closet light

**SAFT 269:** - The ceiling light in the closet has an exposed incandescent bulb which is considered a fire hazard by today's safety standards. The bulb should be removed and replaced with a screw in fluorescent type bulb to correct this unsafe condition.

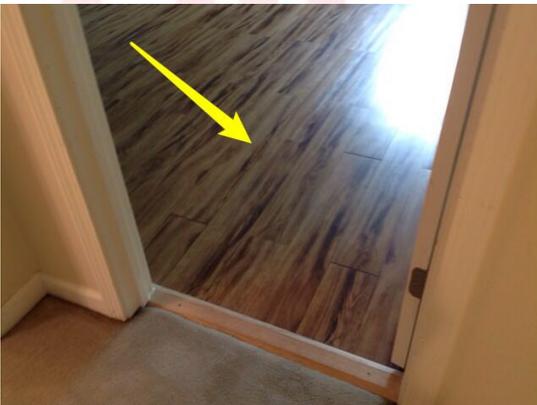
Left rear bedroom #2

**FYI 270:** - There is a slight rise in the floor at the entrance of this bedroom. It is undetermined the reason or cause of this.

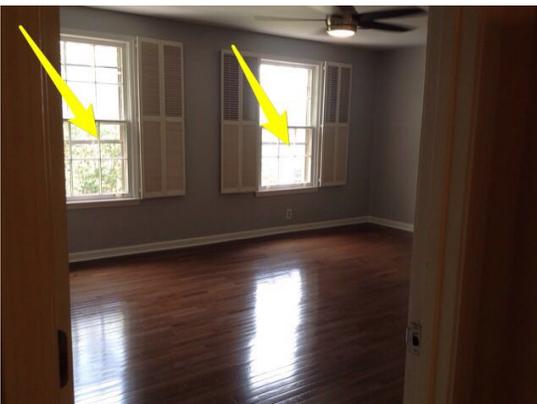
Both master bedroom windows

**REPR 271:** - The assist spring that supports the window in the up position appears broken and needs repaired/replaced for the window to function as designed.

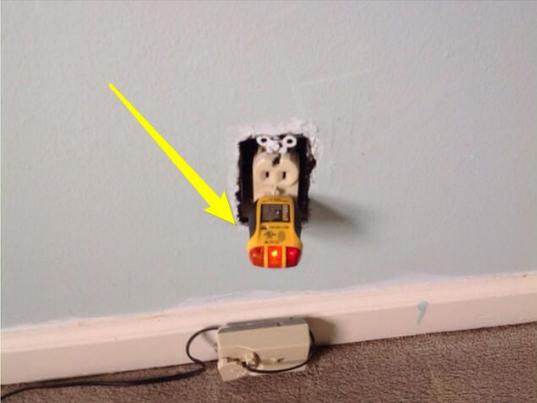
Rear Center bedroom #1

**SAFT 272:** - One electrical outlet found in this bedroom has reversed polarity (hot and neutral wires reversed). This condition should be corrected by a qualified professional.

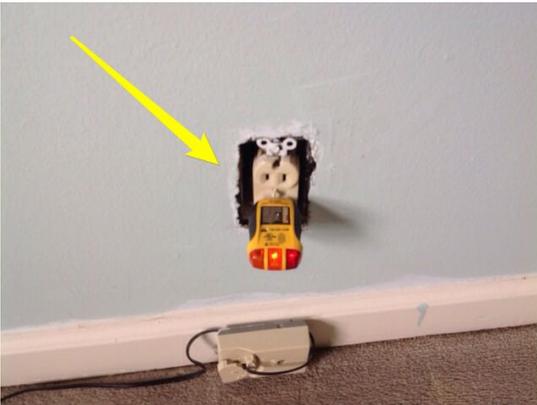
Rear center bedroom #1

**SAFT 273:** - An electrical outlet cover plate was found missing in this room that for safety concerns should be replaced.

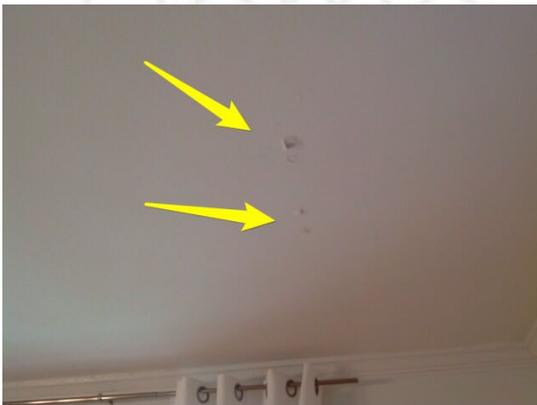
Left front living room

**278:** - Damage was found in the ceiling of the left front living room that is in need of repair.

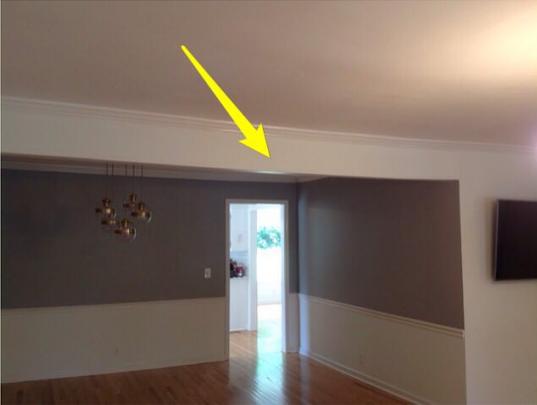
**FYI 279:** - Sagging was noted in the supporting header/beam over the opening between the front living room and dining room. The reason for this condition was undetermined and further investigation is needed.

Sagging between dining & living room

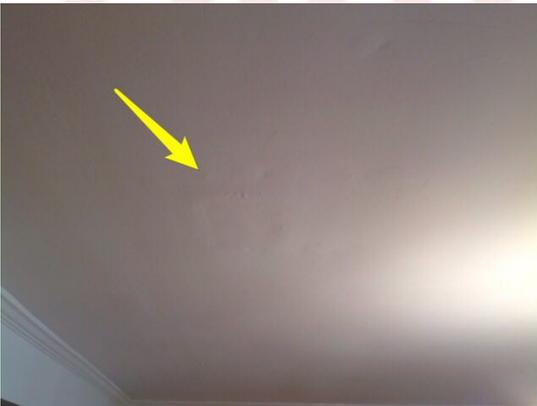
Left front living room

**FYI 280:** - FYI - Portions of the ceiling in the room(s) mentioned below have been previously repaired. It was undetermined the extent of any hidden damage and the reason for the repair or if they were successful.

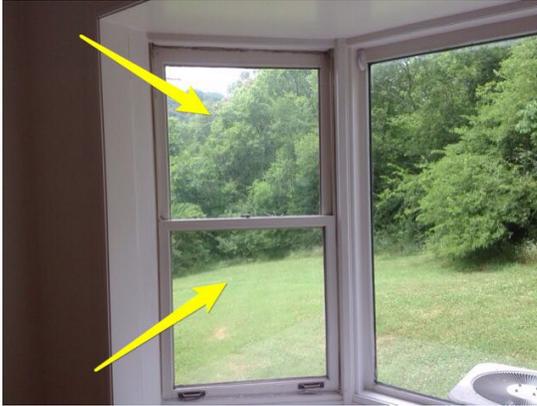
Rear family room

**REPR 282:** - The window(s) in the rooms listed below have a cloudy or wet like appearance indicating a possible defect in the thermal seal between the two panes of glass. This condition also effects the insulation R-value of the window. For maximum heating and cooling efficiency and for the glass to have a clear appearance, replacement is needed. The defective sashes have been identified with blue tape.

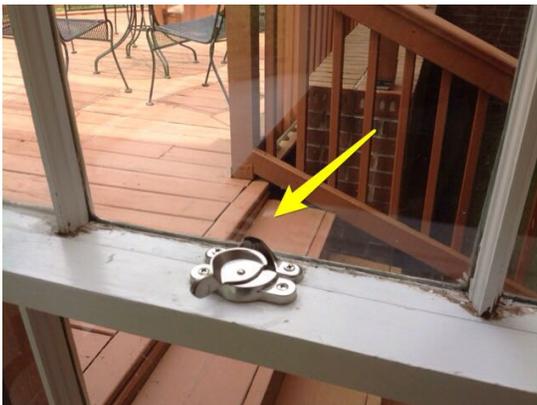
Side window in rear family room

**REPR 284:** - The locking hardware on the side window in the rear family room is broken and needs replaced.

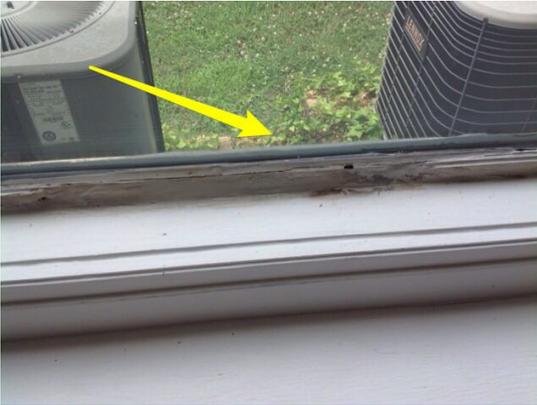
Rear family room window

**285:** - Damage was found in the rear family room window trim/casing that is significant enough that repairs are needed.

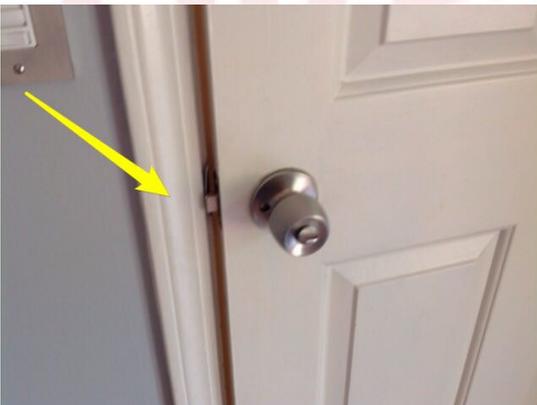
Bonus room

**REPR** **286:** - A misaligned strike plate was noted on the door(s) mentioned below, preventing the door from properly latching when closed. Repair.

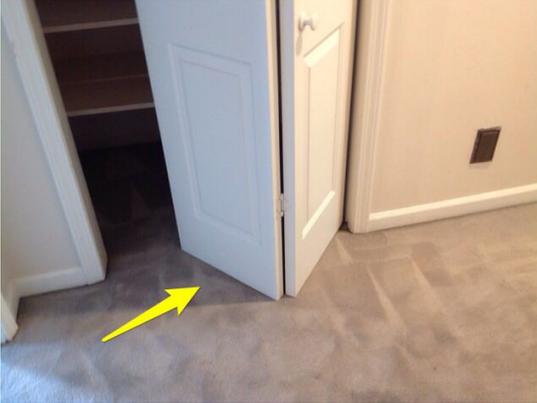
Upstairs hallway closet

**REPR** 287: - The upstairs hallway closet door is interfering with the floor making it difficult to operate. The door will need trimmed for it to function as designed.

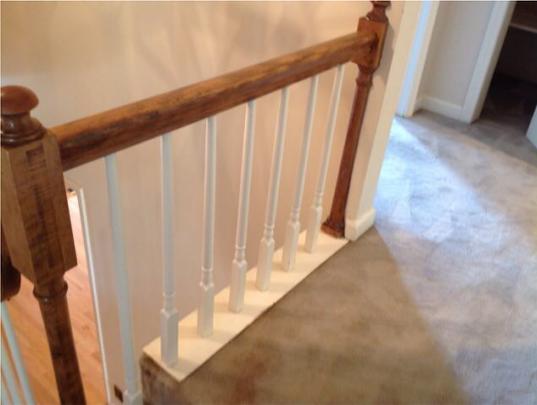
**SAFT 292:** - The handrail on the stairway leading to the upstairs has been installed too low. The railing should be no lower than 34" from the top of the outer edge of the stairway tread. Safety issue.

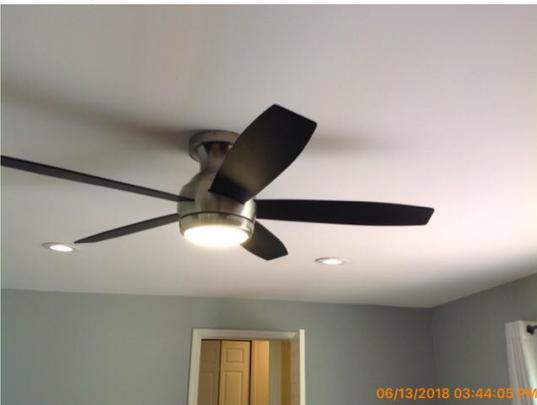
Bonus room

**REPR 294:** - The ceiling fan installed in the bonus room did not function using the remote control. Further investigation is needed.

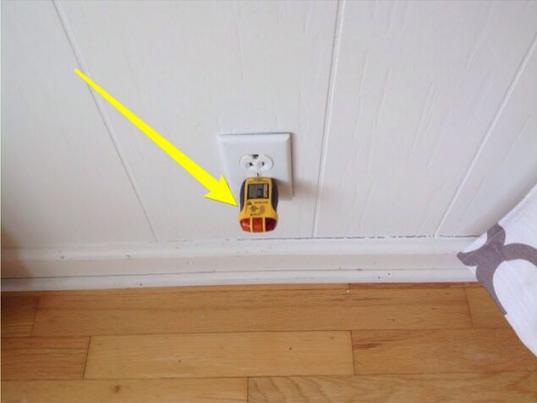
All outlets in this room

**REPR 297:** - Electrical outlets were found in the rear family that did not function when tested. Further investigation and possible repairs are needed by a qualified professional.

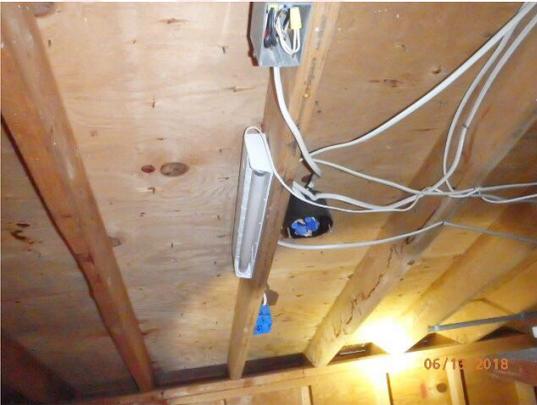
**302:** - Unprofessional electrical wiring was found in the attic closet off of the bonus room that needs further inspected and the necessary repairs made by a qualified electrician.

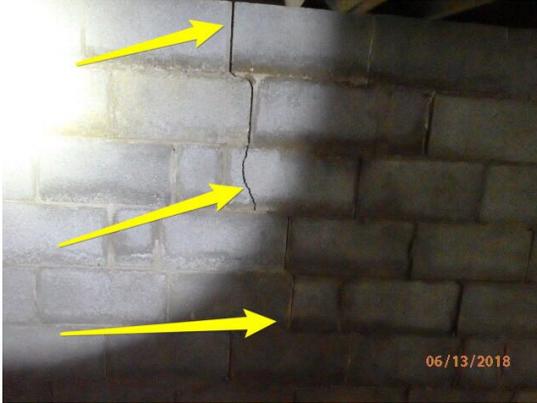
**REPR 312:** - Cracks were noted in the left end foundation block wall in the crawlspace. This may be an indication of settlement or movement in the foundation. Due to the inspector not knowing when the cracks occurred, it is recommended the areas be further investigation by a qualified professional foundation contractor or structural engineer to determine if repairs are necessary.

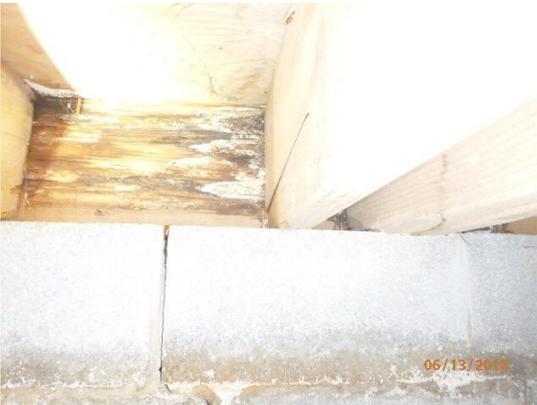
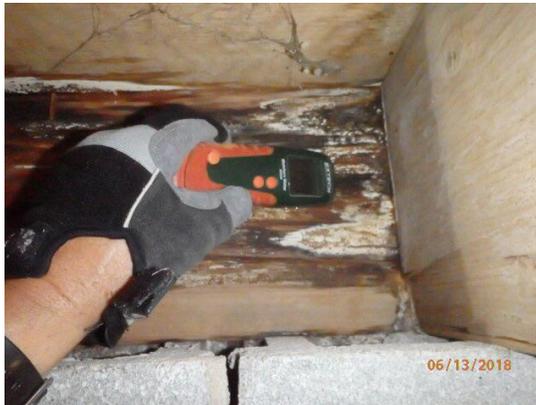
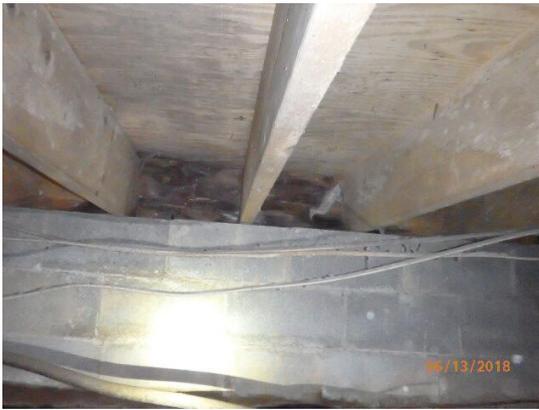
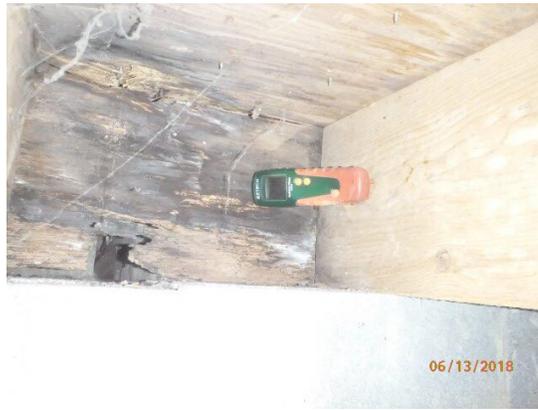
**REPR 320:** - Water damage with elevated moisture damage was noted in the rim joist on the left and right ends of the building. UltraSound recommends further investigation and repair by a qualified professional.

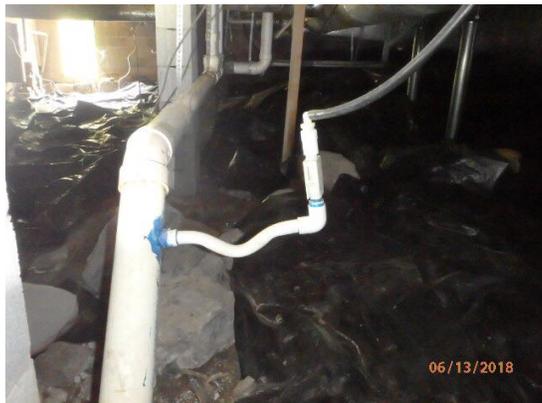
**REPR 339:** - A water filtration system has been removed from the structure. The drain line and plumbing trap for this system has been abandoned in the crawlspace. The drain line should be removed and the plumbing pipe repaired to prevent sewage water and gases from entering the structure.

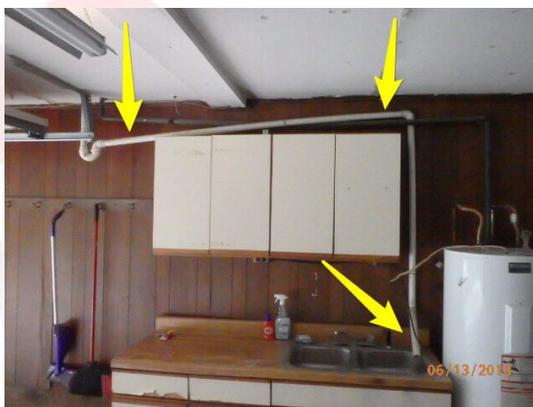
Drain in garage

**REPR 340:** - Unprofessional plumbing has been performed in the upstairs bonus room closet where a sink has been installed. The drain assembly has become disconnected from the sink that is currently draining into the garage lavatory. UltraSound recommends further investigation and repair by a qualified professional.
