# UltraSound

### Confidential Inspection Report

123 Sample Street  
Hompson's Station, TN 37179

Monday, February 26, 2018

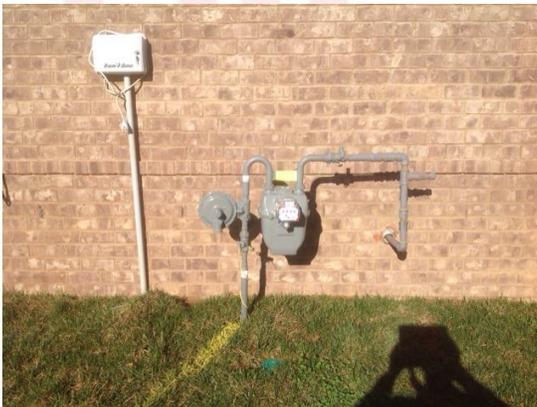
### **LOCATION OF METER**

**40:** - Right side of the house.

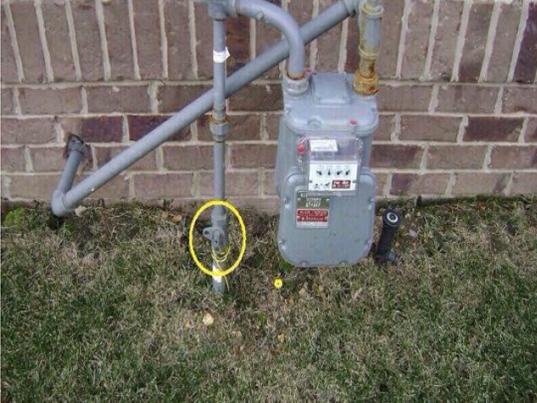
### MAIN GAS SHUT OFF VALVE

41: - The main gas shut off valve is located at the meter base. This is important to know in case of an emergency. Valve can be turned to the off position with an adjustable wrench by aligning up the holes on the meter valve. See location of meter above.

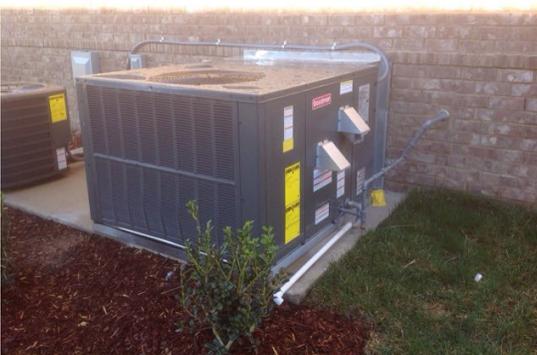
#### UNIT/CONDENSER LOCATION

74: - Right Side of house.

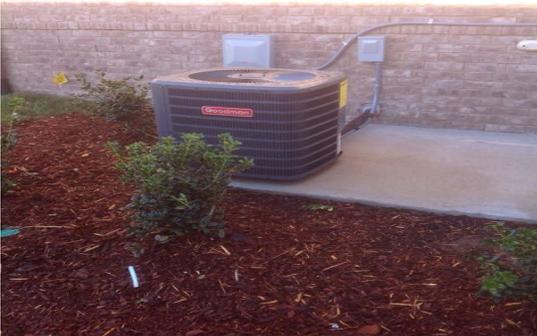
### UNIT/CONDENSER LOCATION

**87:** - Right Side of house.

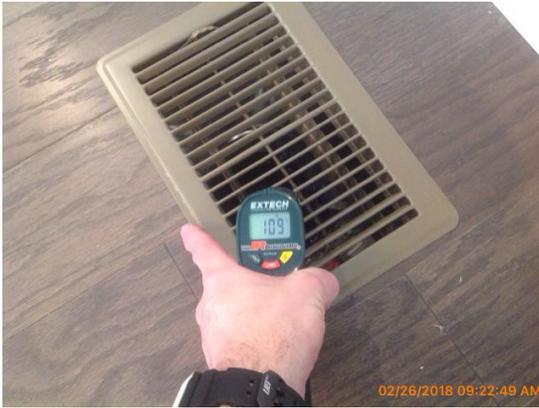
## UNIT TESTED

**106:** - Yes- The heating system was operated and tested using normal controls.

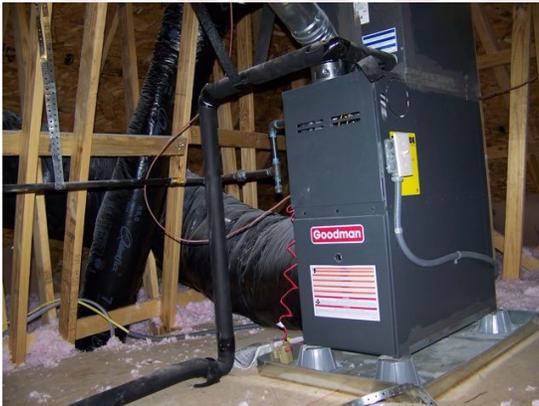
### **HEATING SYSTEM LOCATION**

**119:** - The heating unit is located in the attic.

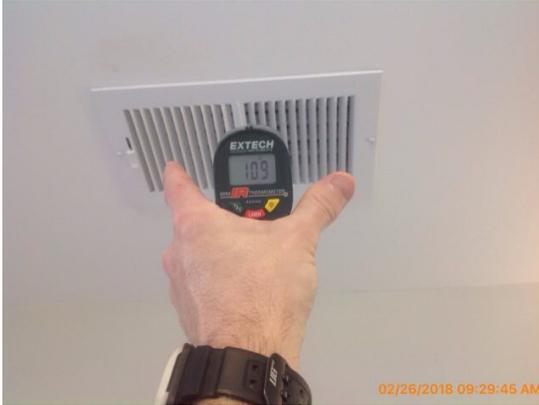
### **UNIT TESTED**

**126:** - Yes- The heating system was operated and tested using normal controls.

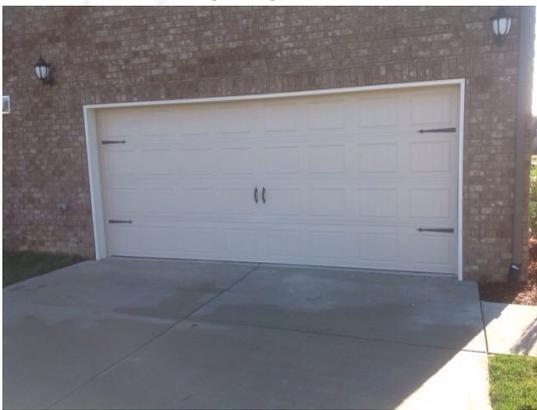
**SIZE OF GARAGE**

**162:** - Two car garage.

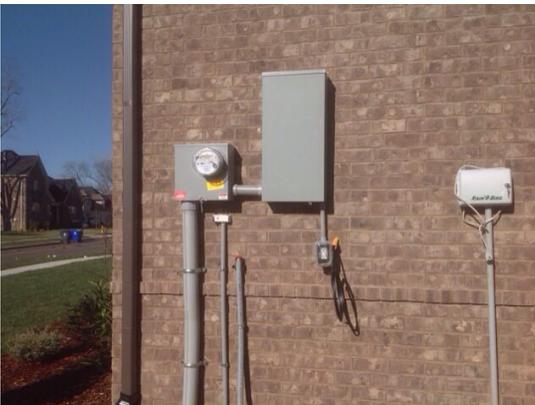
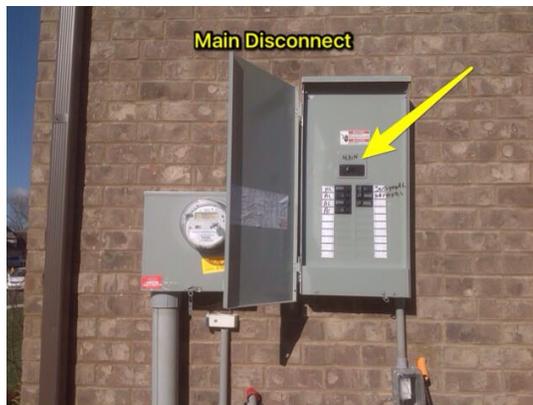
### **MAIN POWER DISCONNECT**

**FYI 182:** - Located on the exterior wall by the meter base. This is important to know in case of an emergency.

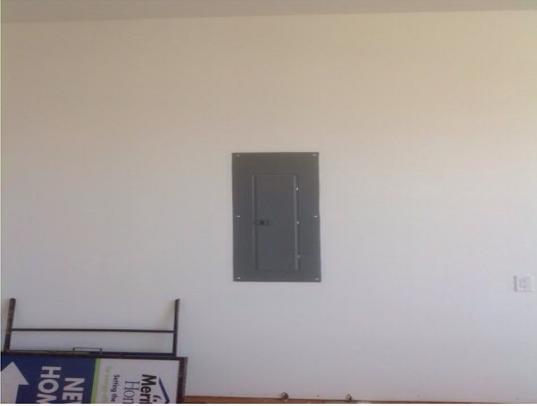
**DISTRIBUTION PANEL LOCATION**

**185:** - Garage

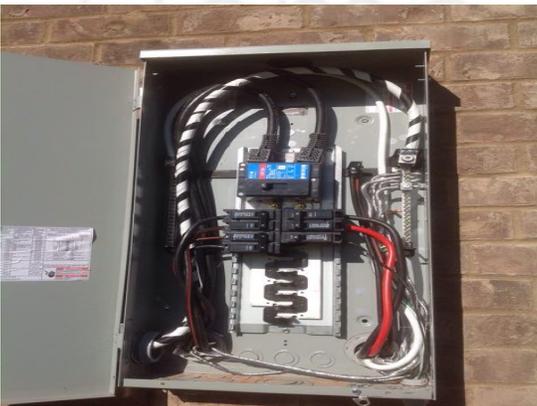
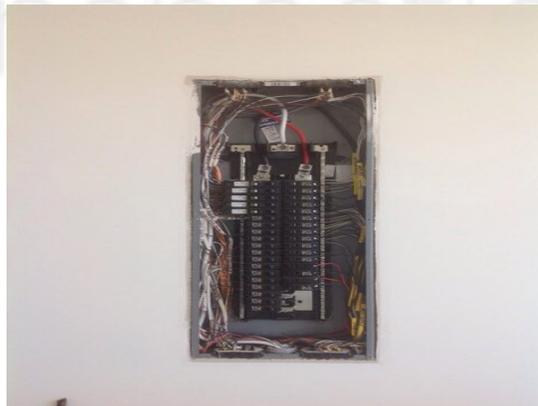
**PANEL COVER REMOVED**

**188:** - Yes

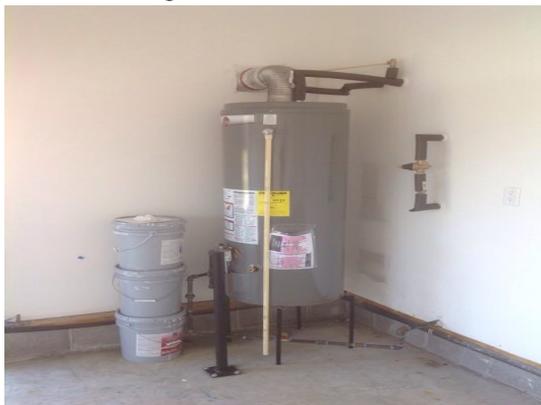
#### LOCATION

202: - Garage

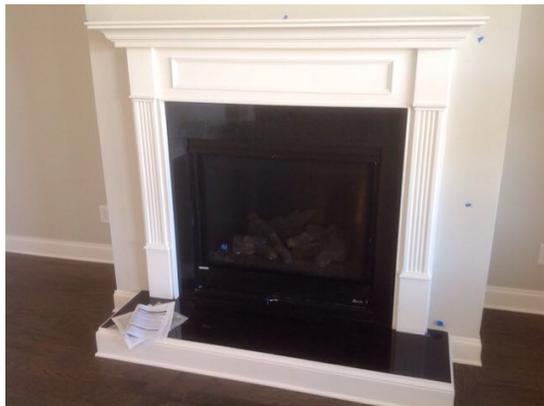
### LOCATION OF FIREPLACE

228: - Living Room

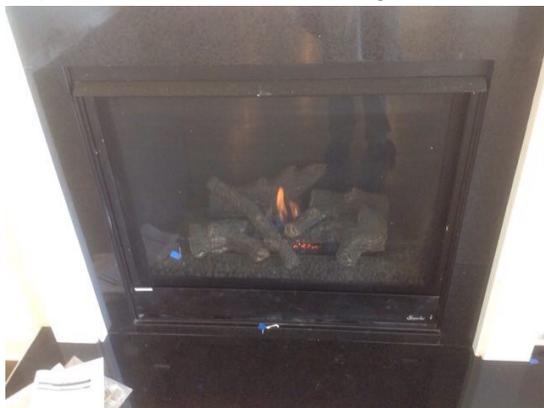
### GAS LOG SET TESTED

234: - The pilot light was in operation at the arrival of the inspection and the gas log set was tested and appeared to function as designed.

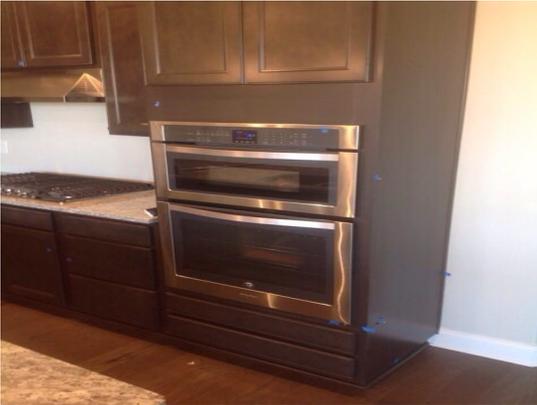
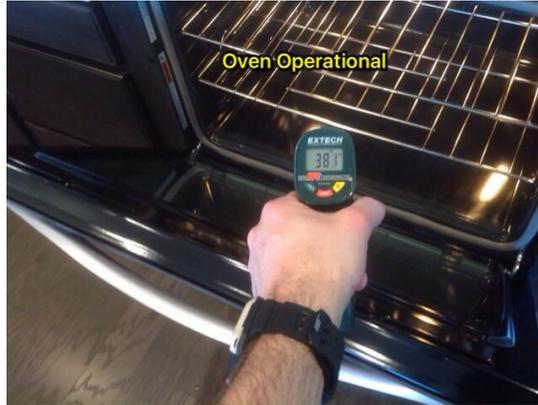
**RANGE/OVEN CONDITION**

**261:** - There is a built-in range top and oven that appeared to function as designed during the inspection. The timers and temperature settings were not tested and are not part of this inspection.

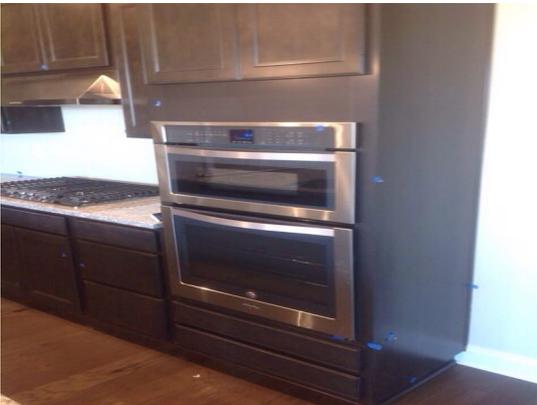
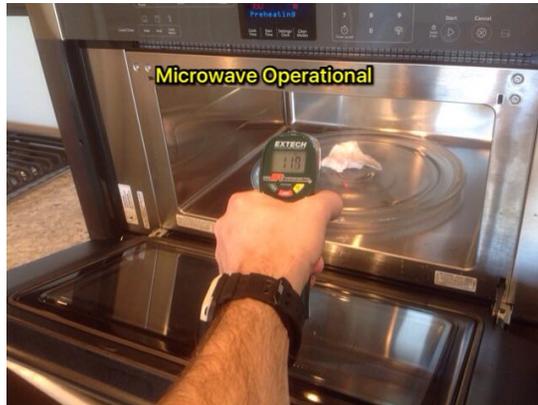
**MICROWAVE OVEN**

**263:** - The built-in microwave oven was tested by heating up a wet paper towel and appeared to function as designed.

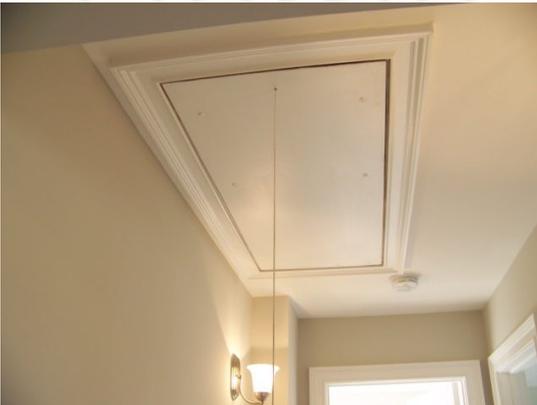
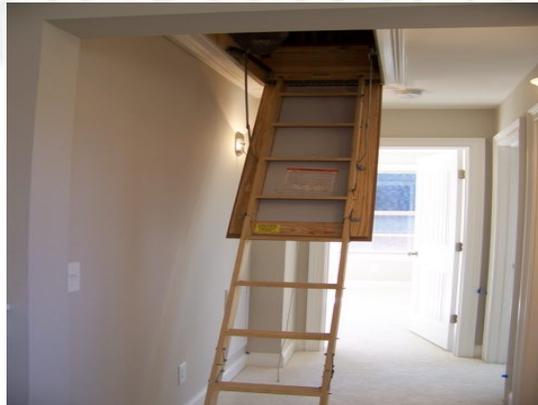
### ATTIC ACCESSIBILITY

**329:** - There is a pull down ladder installed.

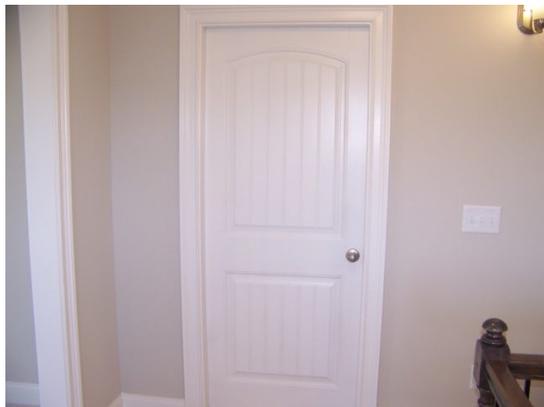
### **ATTIC WALK-IN DOOR CONDITION**

**332:** - Satisfactory - The attic door open and securely closed as designed.

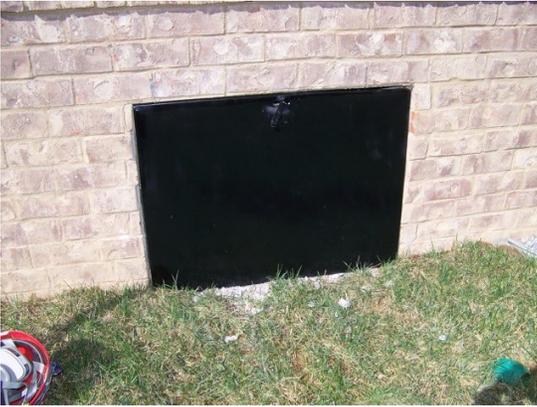
**LOCATION OF CRAWLSPACE ENTRANCE**

**350:** - Exterior

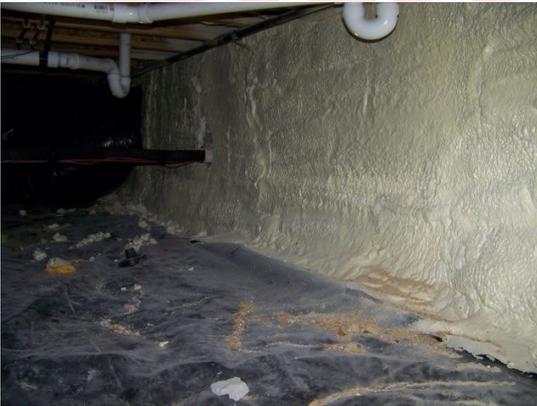
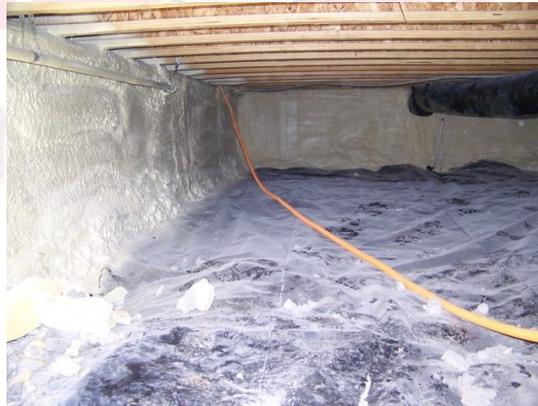
**PERCENT INTERIOR FOUNDATION WALL EXPOSED**

**353:** - The crawlspace is fully encapsulated and the foundation walls have been covered with a spray foam insulation making it impossible to locate or identify any type of cracks or defects that may be present.

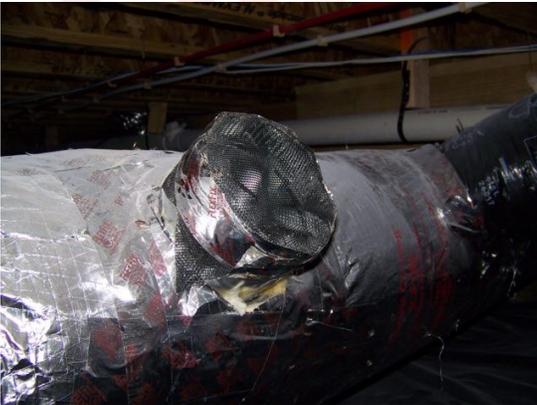
### **CRAWLSPACE VENTILATION**

**FYI 368:** - The crawlspace is a conditioned type crawlspace that has no ventilation vents. It is however being supplied conditioned air from a vent from the HVAC system which is required to meet today's minimum building standards.

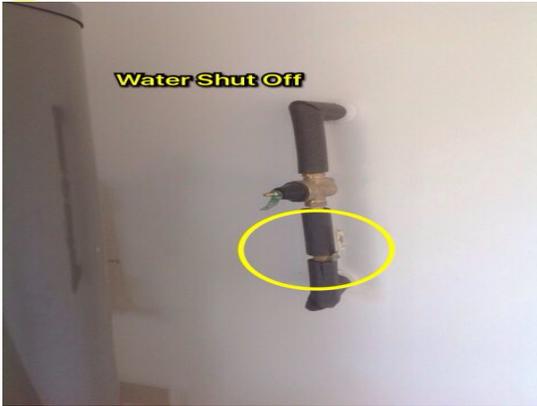
## MAIN WATER SHUTOFF VALVE LOCATION

**FYI 378:** - Located behind or above the water heater.

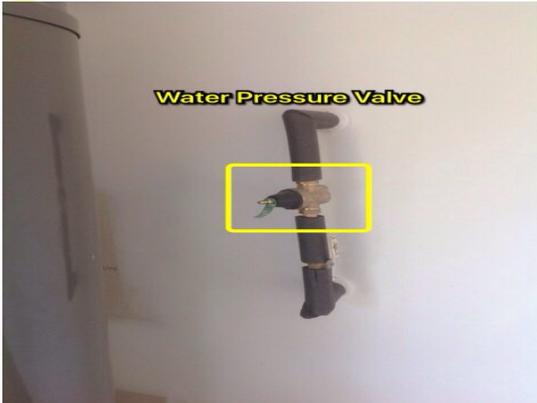
## WATER PRESSURE REGULATOR VALVE PRESENT

**FYI 379:** - Located next and downstream of the main water shut off valve.

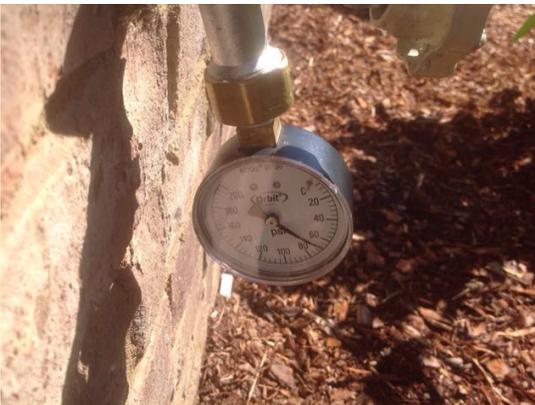
## WATER PRESSURE

**380:** - Water pressure was measure at either one of the exterior hose bibs or at the laundry room washing machine connection. The pressure measured was found to be within the acceptable range of 40 to 80 pounds per square inch.

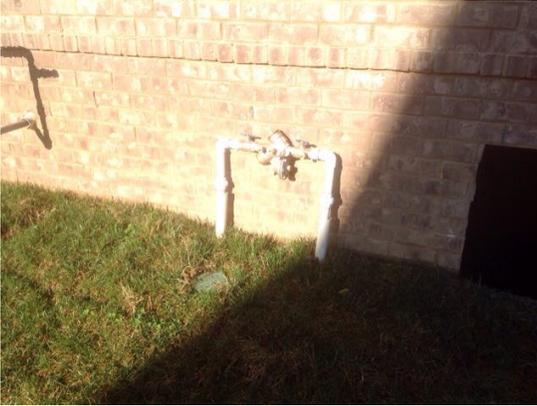
## LAWN SPRINKLER SYSTEM

**FYI 395:** - FYI - A lawn sprinkler system was noted during the inspection. Sprinkler systems for various reasons are beyond the scope of this inspection.

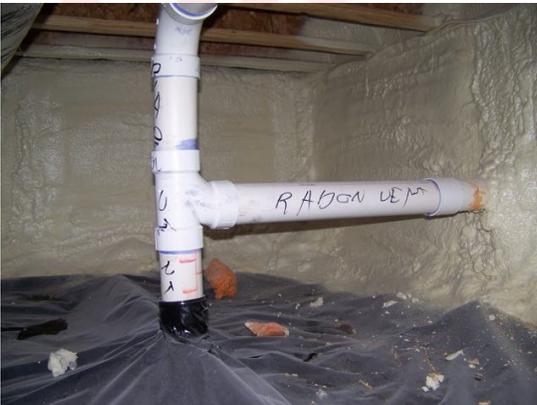
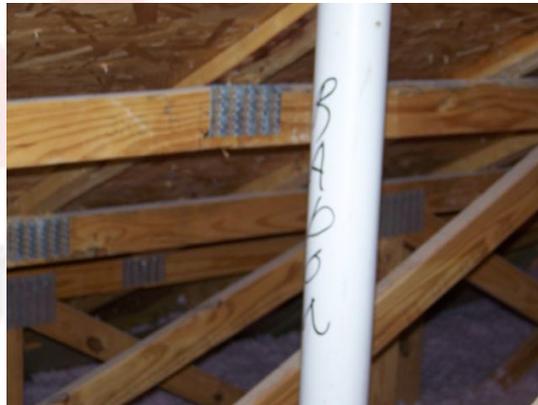
## RADON PASSIVE MITIGATION SYSTEM

**396:** - Yes - A radon passive mitigation system was installed in the building at the time of construction which allows the building to be inexpensively mitigated in case elevated radon levels are ever measured in the building.
